Implementing Diverse Bank Stabilization Measures to Contain and Capture Lead-Contaminated Sediment

Joseph Collum, P.E., Civil Engineer (Hydraulics), U.S. Army Corps of Engineers, Saint Louis, MO, joseph.b.collum@usace.army.mil

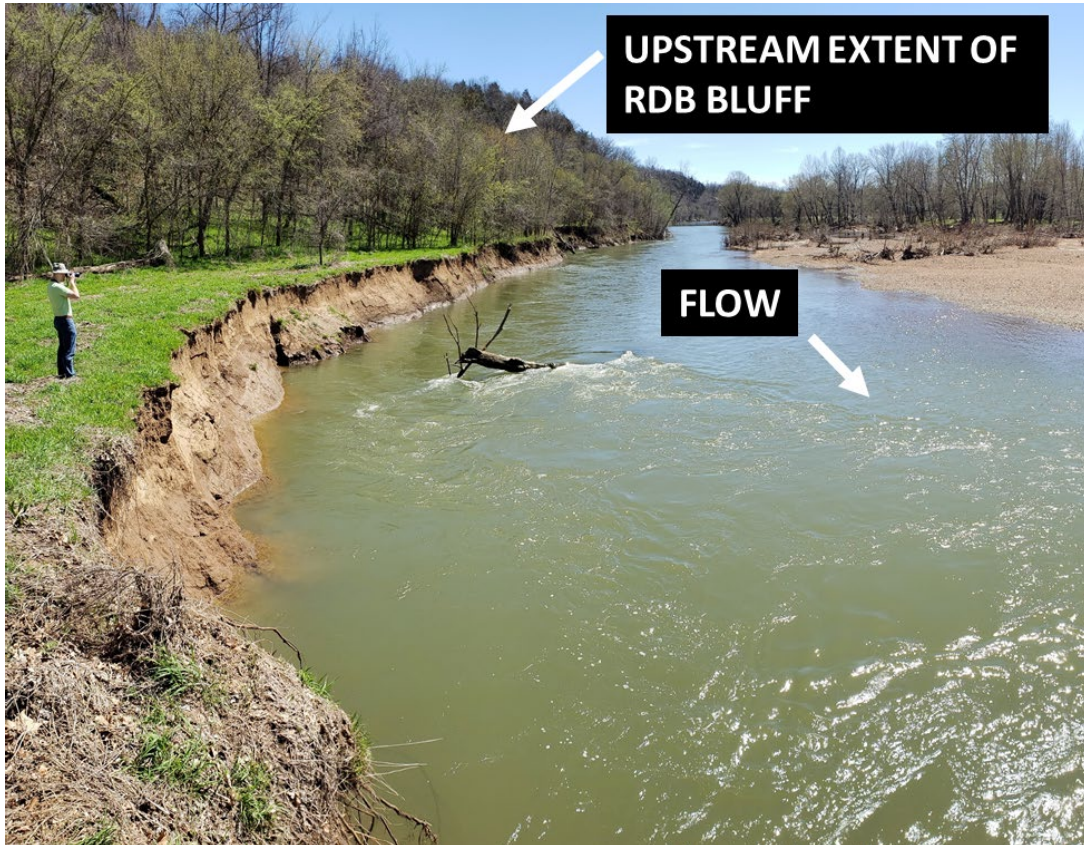
Bank 1 (Figure 5) is the furthest upstream bank in this project. It is about 12 feet tall from top of bank to thalweg during low flows.

Figure 5. Bank 1 pre-construction condition (2019), facing upstream (east-southeast)

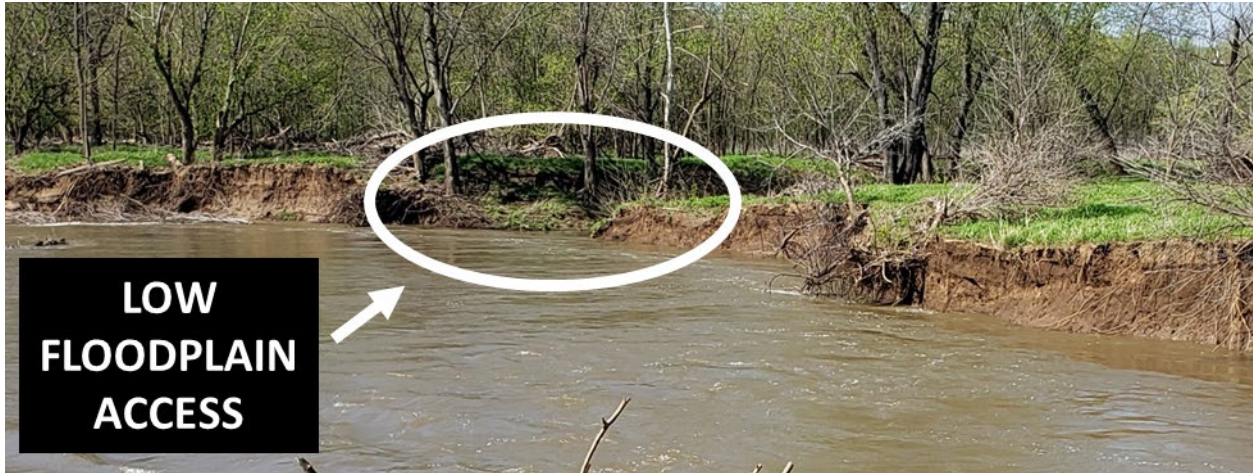
The river is eroding into the low floodplain at bank 1 and ultimately has potential to allow the Big River to cut through thousands of feet of low floodplain (between banks 1 and 3), shortening the length of river and increasing the Big River's gradient. In one location at this bank, floodplain access begins at ~90% ACE (1.1-year) flows (Figure 6).

Figure 6. Bank 1 low floodplain access (2019, higher flow than previous figure), facing downstream

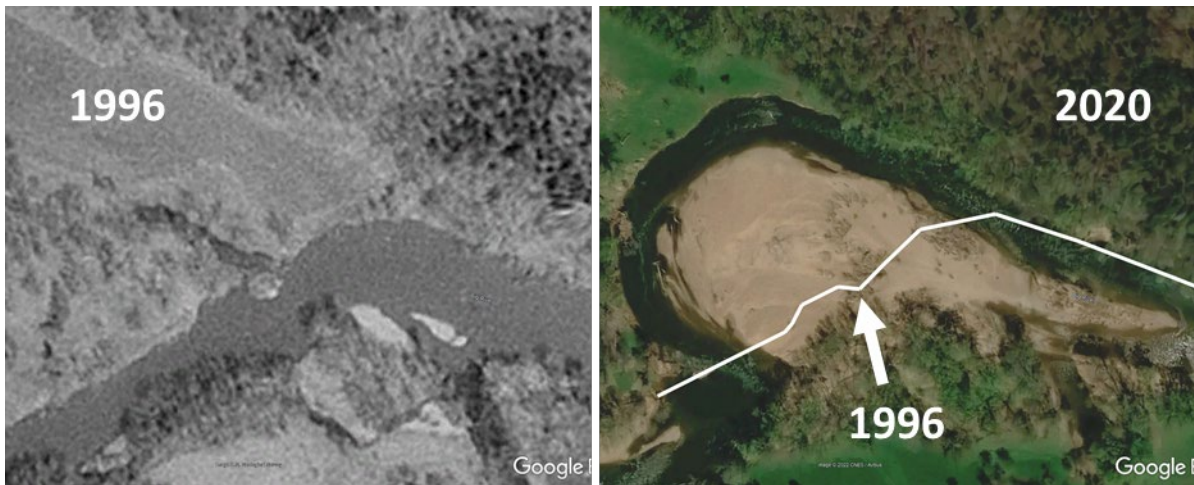
Between 1996 and 2020, bank 1 has eroded laterally by 360 feet at its apex, releasing about 4.0 acres of lead-contaminated sediment into the Big River (Figure 7).

Figure 7. Riverbank erosion at bank 1 between 1996 and 2020; flow from right

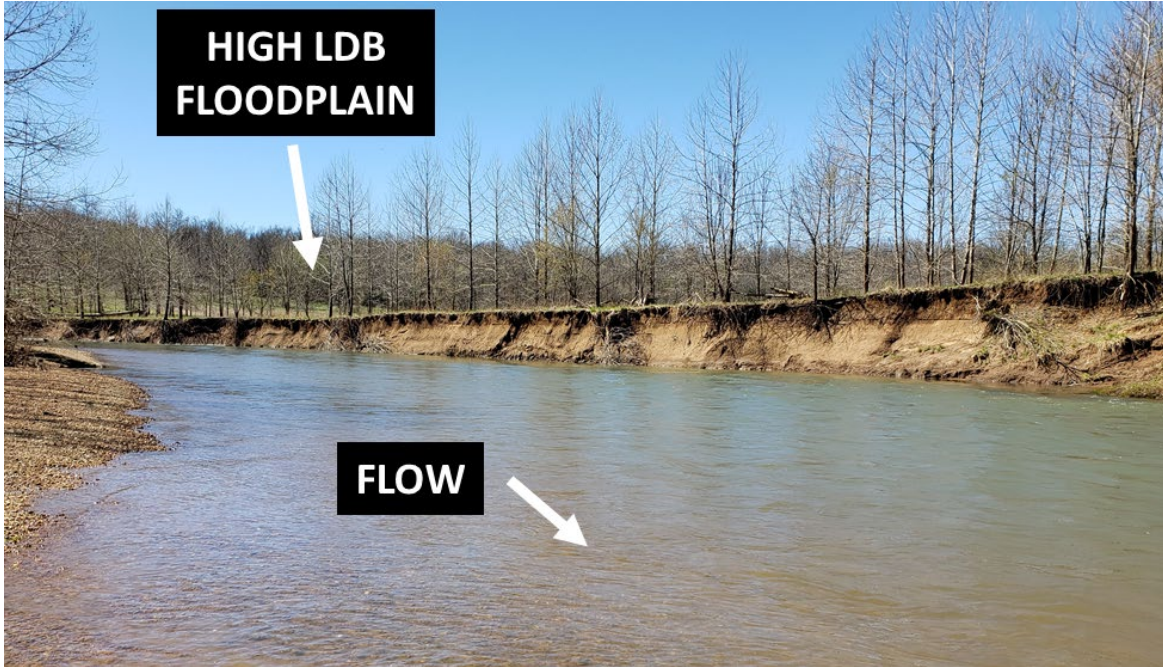
Bank 2 (Figure 8) is the middle bank in this project. It is eroding into a high floodplain on the LDB. It is about 20 feet tall from top of bank to thalweg during low flows. A hard point, thought to be a bedrock shelf, is present at the exit of bank 2 as it transitions into bank 3, immediately downstream.

Figure 8. Bank 2 pre-construction condition (2019), facing upstream (southwest)

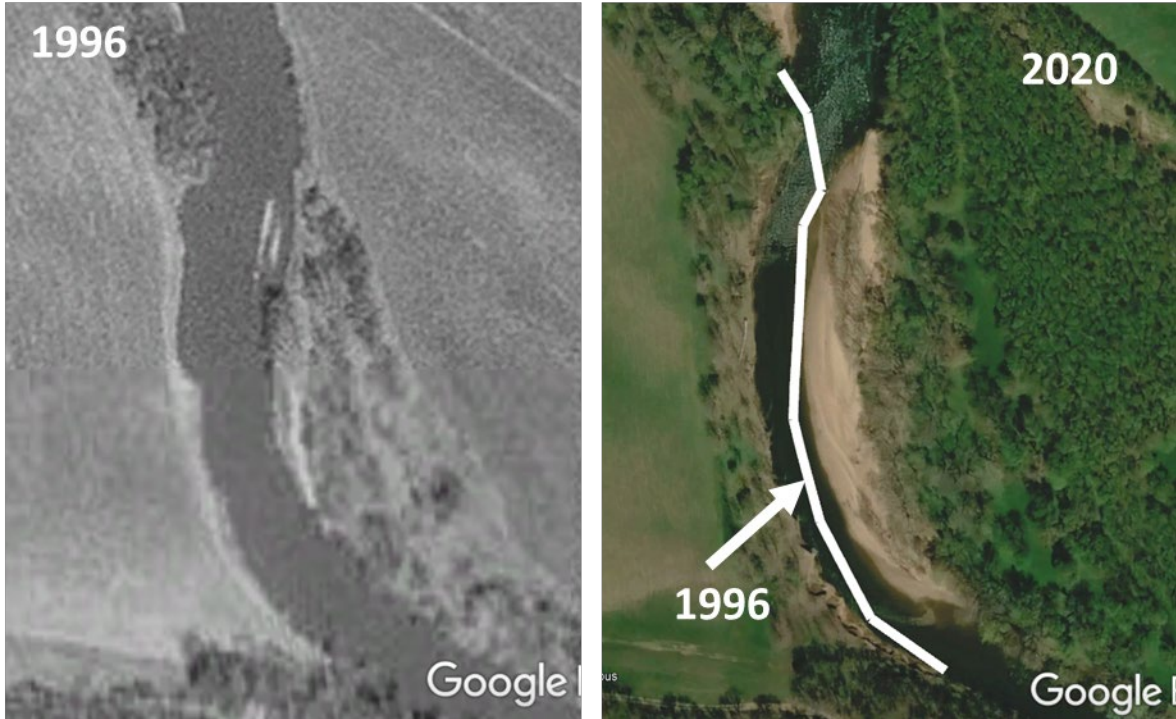
Between 1996 and 2020, bank 2 has eroded laterally by 110 feet at its apex, releasing about 1.6 acres of lead-contaminated sediment into the Big River (Figure 9).

Figure 9. Riverbank erosion at bank 2 between 1996 and 2020; flow from bottom

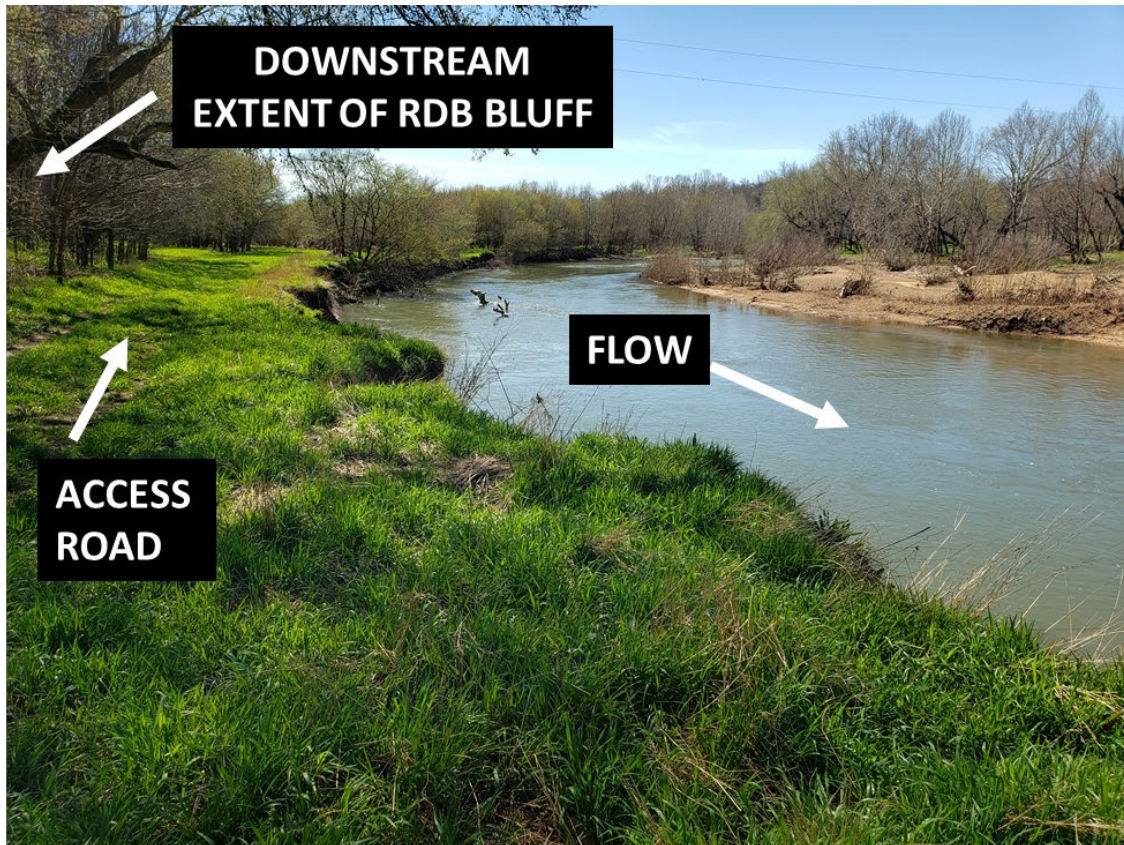
Bank 3 (Figure 10) is the furthest downstream bank in this project. It is about 15 feet tall from top of bank to thalweg during low flows. This bank was eroding into the sole access road to the landowner's bottomlands, which was also used for access to bank 1. At the time of construction, the access road, which once had a floodplain buffer of about 180 feet between it and the river, had only 3 feet of buffer.

Figure 10. Bank 3 erosion site, pre-construction (2019), facing upstream (east-southeast)

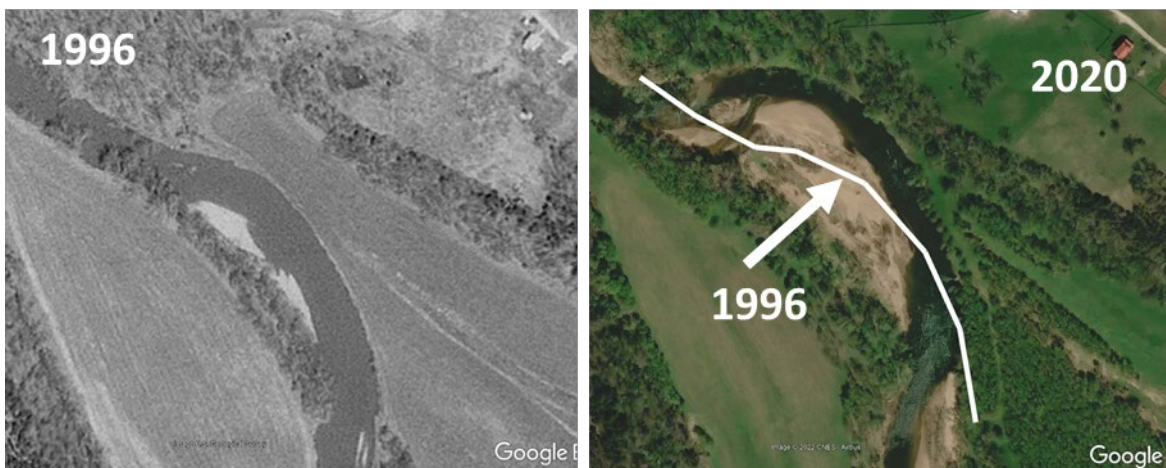
Between 1996 and 2020, bank 3 has eroded laterally by 250 feet at its apex, releasing about 3.3 acres of lead-contaminated sediment into the Big River (Figure 11).

Figure 11. Riverbank erosion at bank 3 between 1996 and 2020; flow from bottom

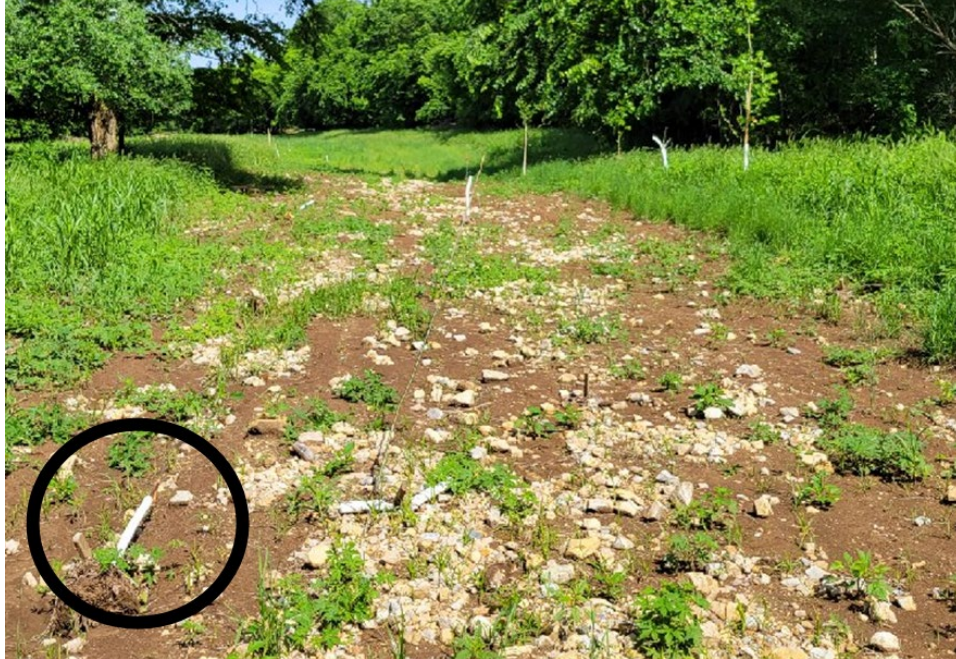
Containerized trees were significantly damaged (Figure 24), with an estimated survival rate of <10%. This does not factor in natural mortality due to factors beyond damage due to flooding.

A portion of the floodplain was used as a haul road and staging area for stone, which was designated to be removed prior to contract closure. Individual riprap stones and large quantities of road gravel and geogrid foundation material are still present in the floodplain (Figure 24). The presence of discrete sections of gravel hundreds of feet from bank 1 (and likely deposition distance) suggest that much of this material may have been covered or buried instead of removed and has since been exposed by soil erosion due to overbank flooding. Pre-construction photos also indicate that some quantity of similar material was present in some locations of the floodplain prior to construction.

Figure 24. Floodplain monitoring - damage to containerized trees and presence of gravel and stone from construction

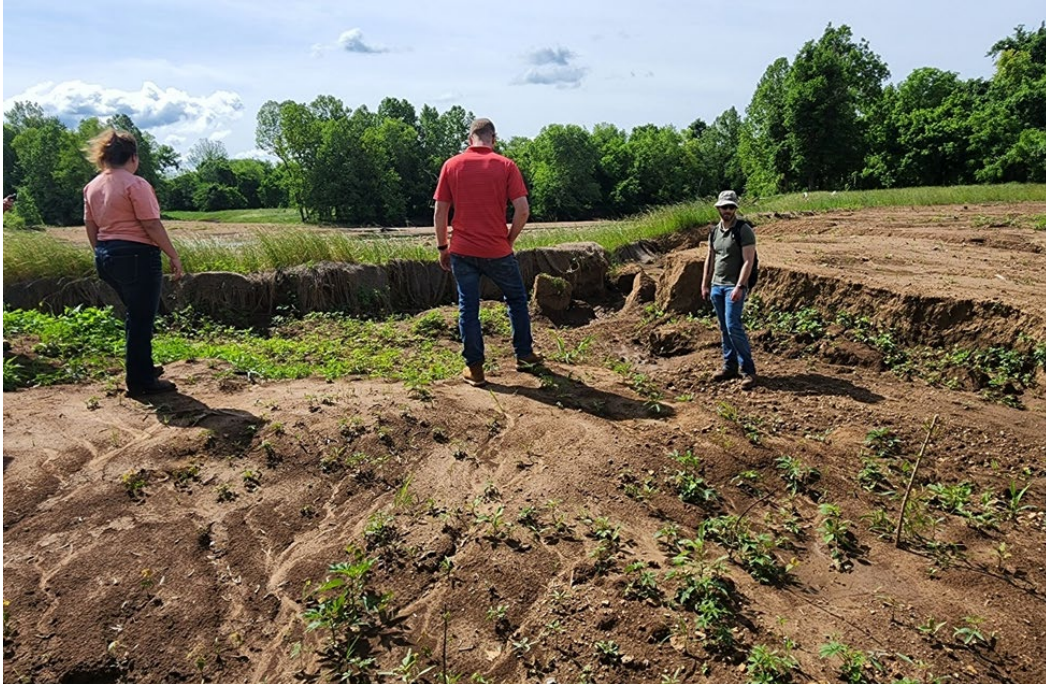
- Significant deposition of suspended sediment has occurred in most of the areas bounded by the LPSTP, tie-backs, and sloped bank.
- One section of upper bank has been eroded by high flows exceeding ~2-year floods (Figure 25). The eroded section is about 20-30 feet wide, and the surrounding 30-40 feet shows very minor scour as well. The total width of eroded and scoured area is about 60 feet. This area is a concern because it will continue to be eroded deeper and wider during future floods. In the process, this deepening and widening will result in more concentrated floodplain flow within the high flow channel between banks 1 and 3, which is not consistent with how the project was intended to function overall.

Figure 25. Bank 1 monitoring - scour at crest of shaped bank. Bluff behind photographer; floodplain to the right; Big River flowing from left.

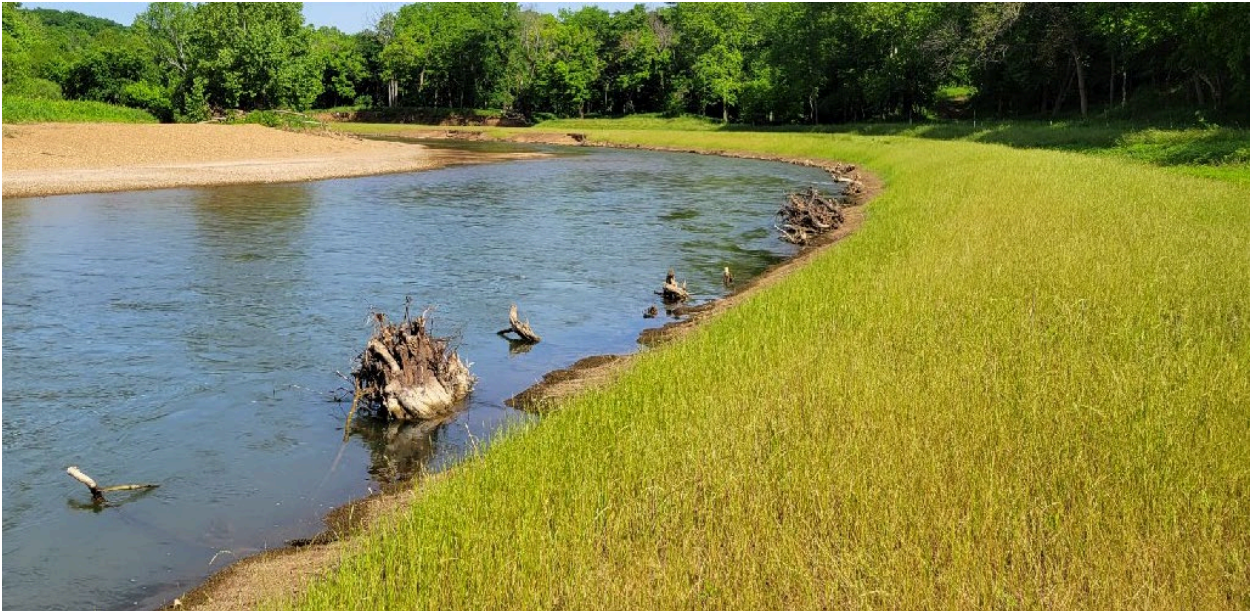
- This bank is performing well overall (Figure 26). The riprap on the entry portion is holding well and there is fresh deposition on top of the riprap, covering it to the point of hiding it in some places. The floodplain bench also has fresh deposition and is showing strong vegetative growth. The upper bank is also holding well, with no signs of damage.

Figure 26. Bank 3 monitoring - performing well overall. Facing downstream.

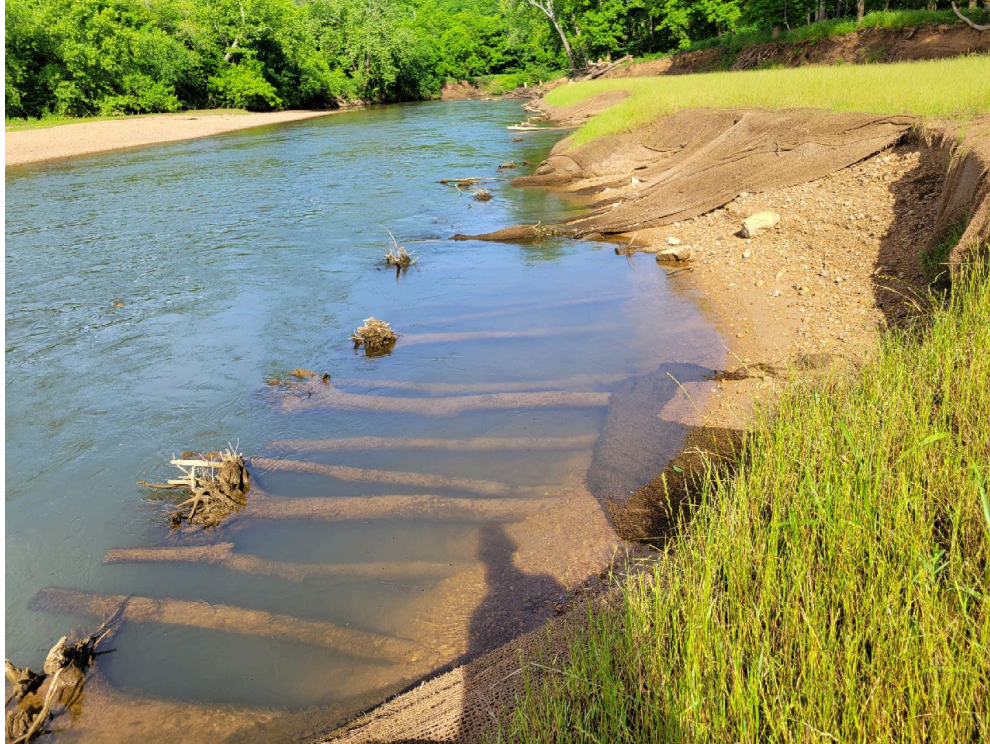
- The toe wood appears to be holding well in most places. However, there is one section about 80 feet long that contains two sections of significant erosion about 60 feet long in total (Figure 27). This erosion extends from the top of the logs to the top of the low floodplain bench, or about 4-5 feet vertically and about 20-25 feet laterally into the low floodplain bench.

Figure 27. Bank 3 monitoring – scour above one section of toe wood. Facing downstream.

The primary failure mechanism causing scour is hydraulic, with the river attacking the portion of the bench between the toe wood and the top of the constructed floodplain bench. Therefore, portions of the toe wood that were not initially ballasted with stone and are not yet scoured will be supplemented with stone revetment. Portions of the bank that have been scoured will be spanned with LPSTP along the originally constructed bankline. The portion of the bank between top of LPSTP and top of bench will be built up using soil lifts (live brush layering) wrapped by TECF.
