Impacts of a Persisting Flood on the Missouri River's Bank Stabilization and Navigation Project

Heather Shaughnessy, Hydraulic Engineer, United States Army Corps of Engineers,
Kansas City, Missouri, Heather.H.Shaughnessy@usace.army.mil

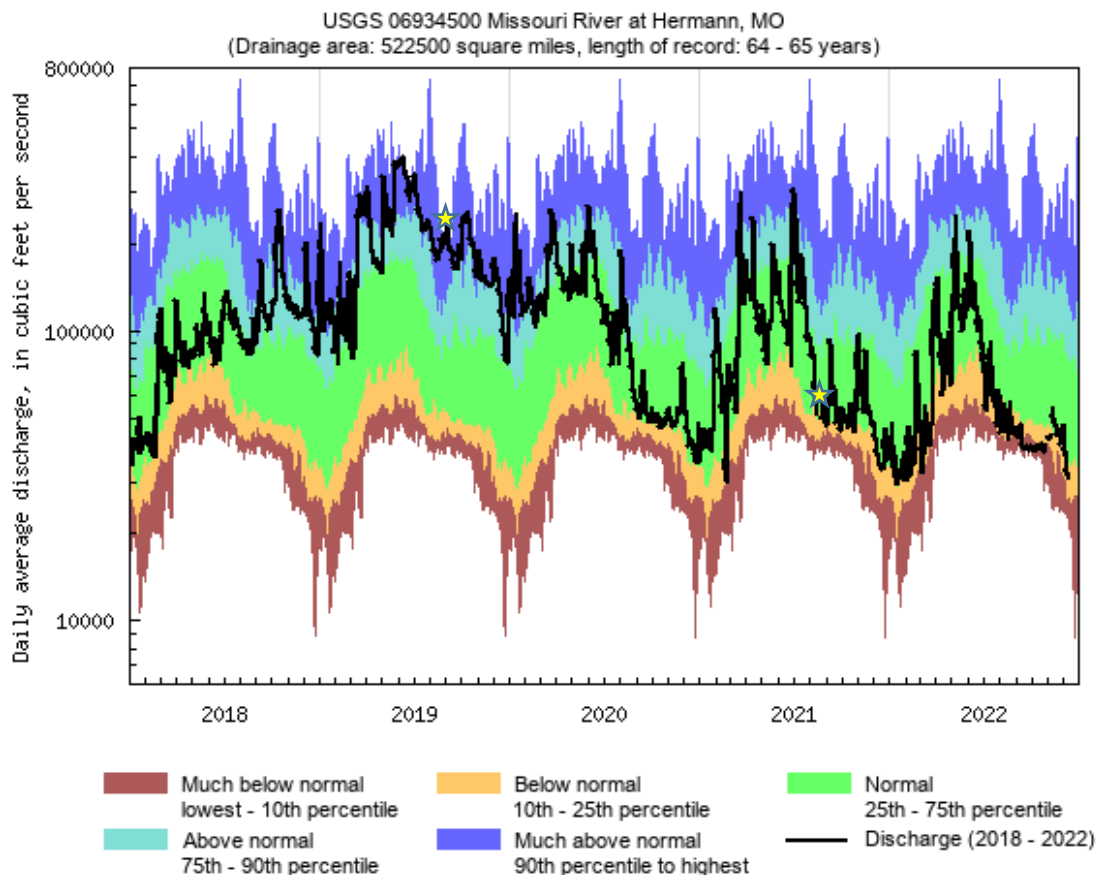
Figure 3 shows the USGS daily recorded discharges (shown as a black line) at Hermann, Missouri between 2018 and 2022. Daily flow statistics for the period of record shown using the solid bands in the background provide a relative historical comparison of the discharges experienced in the past five years.

Figure 3. Daily average discharge from 01 January 2018 to 31 December 2022 at Hermann, MO USGS 06934500 gage at RM 97.9, overlain daily flow statistics over the post-dam period of 1957-2022 for this gage. Stars indicate collection date of 2019 and 2021 surveys shown in Figure 6

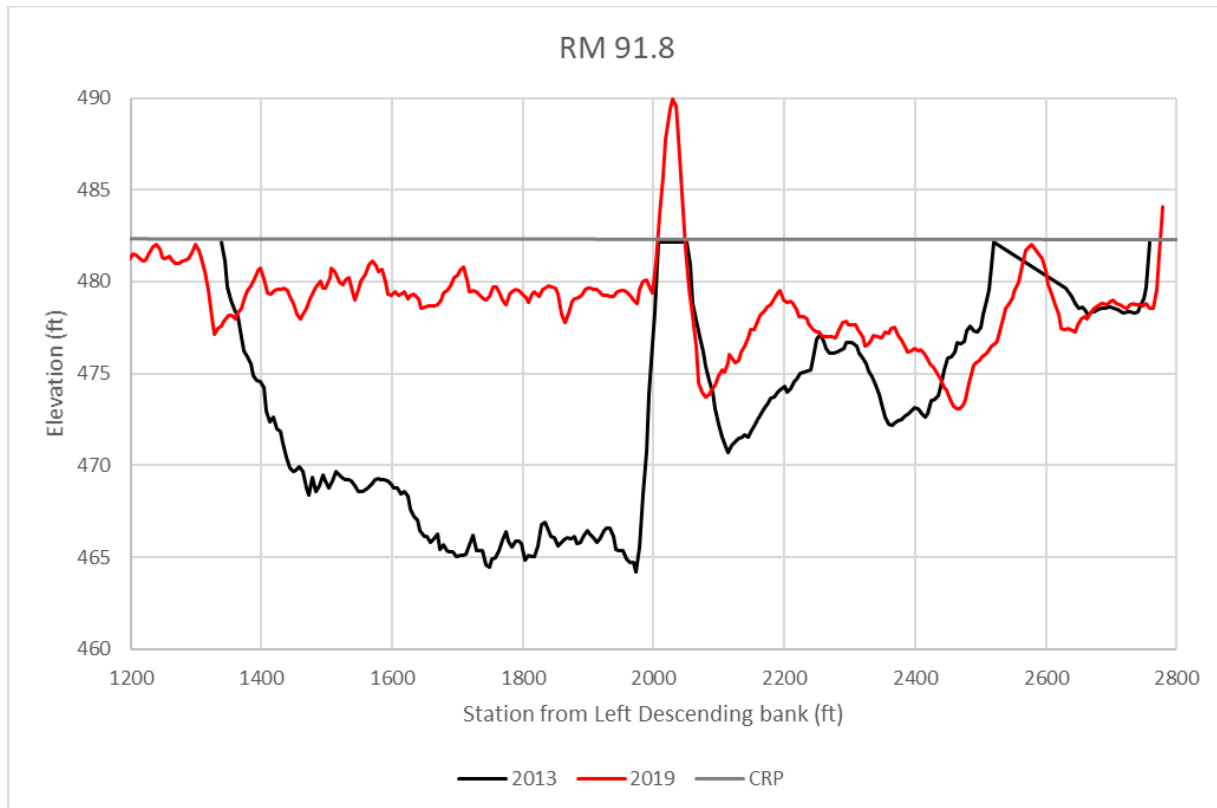
During the period of extended high flow between 2019 and 2020, the riverbed experienced a leveling effect. The main channel experienced aggradation on the order of 15 feet and the channel margin in several location degraded. This resulted in more uniform cross sections (Figure 4) that was evident across the BSNP system. Given high stages exceeded the BSNP structures by several feet for over a year and high flows utilized the floodplain for several

months, the lack of confinement of flow between the BSNP structures and the added sediment loads from a wider cross section reduced the energy needed to flush out the main channel. When comparing the cross sections in Figure 3, note that the water surface elevation in 2019 at RM 91.8 was about 14 feet above the CRP (497') and about 0.3 feet below CRP in 2013 (482 ft). Depth in the navigation channel (approximate stationing between 1600-2000) was about 17 feet deep in the 2019 survey and about 15 feet deep in the 2013 survey with the 2013 stage 15 feet lower than in 2019.

Figure 4. Cross Section at River Mile 91.8, Construction Reference Plane (CRP) shown to indicate water surface elevation at which flow is exceeded 75% of time during navigation flow support season.

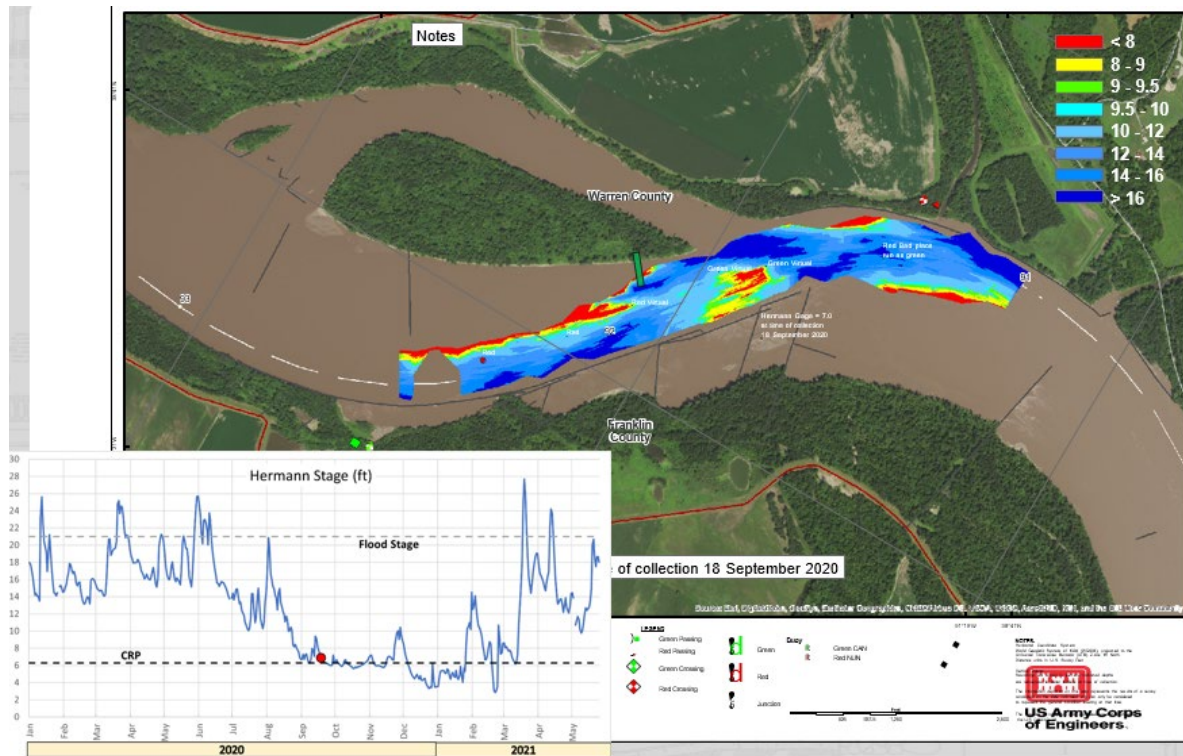
As stages dropped in the Fall of 2020, navigation depths became limited across the Missouri River navigation channel as the sand bed lagged in adjusting to a dramatically lower flow regime. Additionally, damaged river training structures (dikes and revetments) resulted in a slower and less pronounced self-souring effect to aid in deepening the channel back to pre-flood conditions. Navigation surveys reported depths of less than 9 feet at locations scattered throughout the lower 500 river miles of the Missouri River that persisted through 2020 and 2021. Figure 5 provides an example of one the many locations that experienced shoaling.

Figure 5. Navigation Survey at River Mile 91 indicating areas less than 8 feet (red) in the late summer of 2020

The Kansas City District (NWK) utilized every means and method available to mitigate the impacts of the shoaling on navigators. NWK communicated daily the field observations to the navigation industry to include weekly multibeam depth surveys of shallow areas, forecasts, boat traffic, and coordinate locations of shoals and obstructions. Additionally, NWK's River Engineers responded with real time site assessments, split flow measurements, BSNP structure assessments, design, and emergency placement of new and repair of existing river training

structures. Communicate of conditions with frequent surveys was the greatest assets in mitigating the negative impacts to navigations.

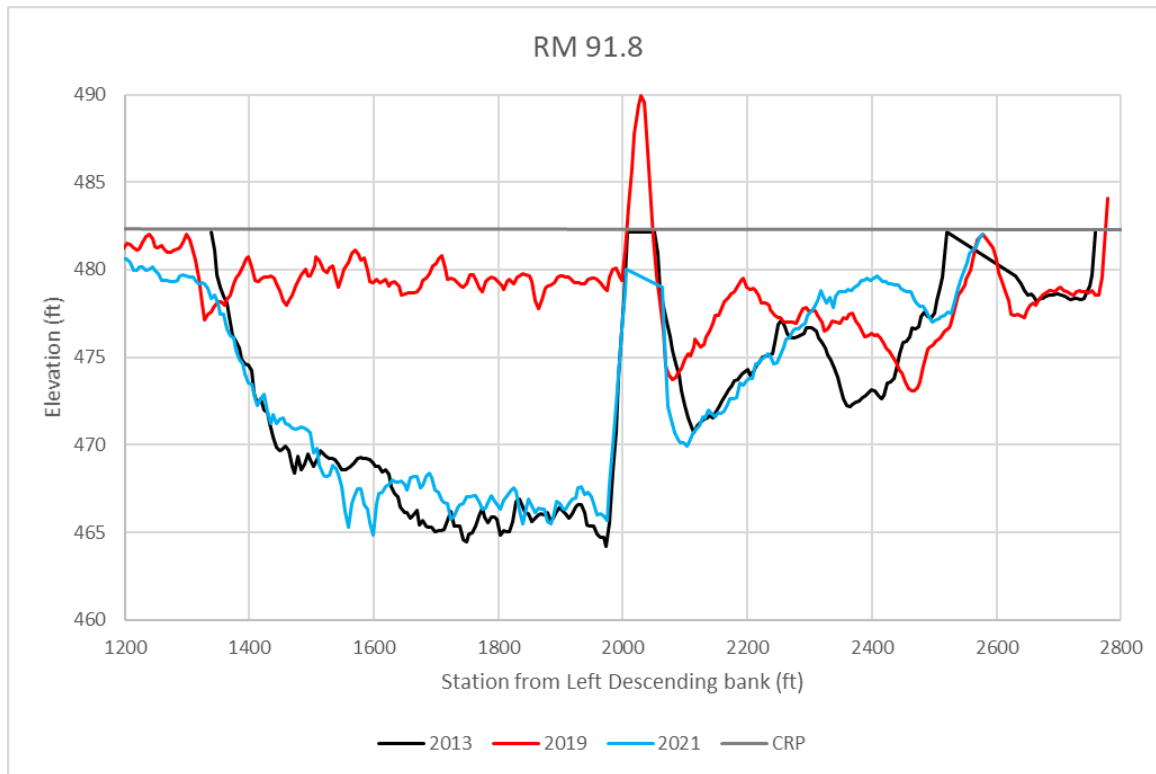
With time, the conglomeration of the emergency river engineering actions and the natural adjustment of the riverbed to a confined flow allowed for the riverbed to respond and adjust to pre-flood conditions. Based on initial observations and comparisons across the BSNP system, the emergency structural work done in the form of new placement and repaired structures accelerated the lowering of the main channel back to pre-flood conditions, which may have taken a longer period and fallen shy of the pre-flood depths if structural interventions were not taken. A further BSNP-wide review of data collected during the 2019-2022 period in light of engineering actions is necessary to confirm this initial hypothesis. Figure 6 shows a return to a similar cross section shape in 2021 as in 2013 with a deepened passable channel on the left descending side of the cross section. Note that in 2021 at RM 91.8 the water surface elevation was about 1.5 feet above the CRP (an elevation of 484 ft).

Figure 6. Cross Section at River Mile 91.8, showing 2021 condition returned to conditions similar in 2013.
