Downstream Impacts of the Rio Coca Regressive Erosion

Introduction

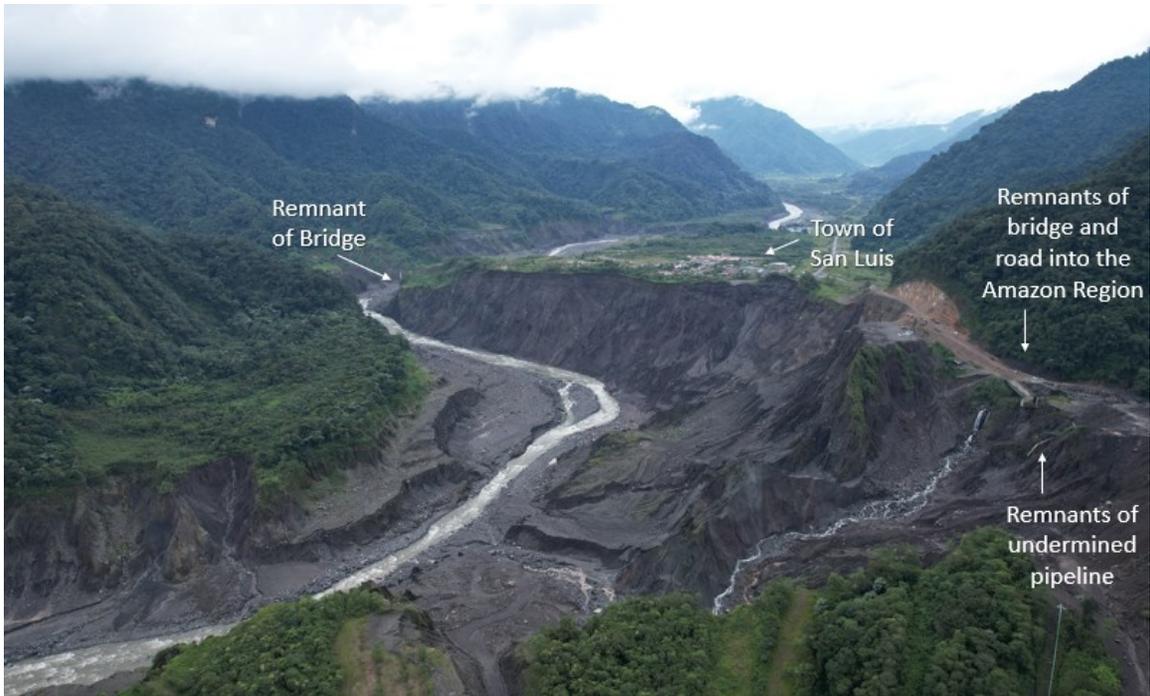
Figure 1. Looking upstream at the canyon formed by of the regressive erosion about 4 km upstream of the former lava dam site (Feb 2023) and some of the affected infrastructure and towns.

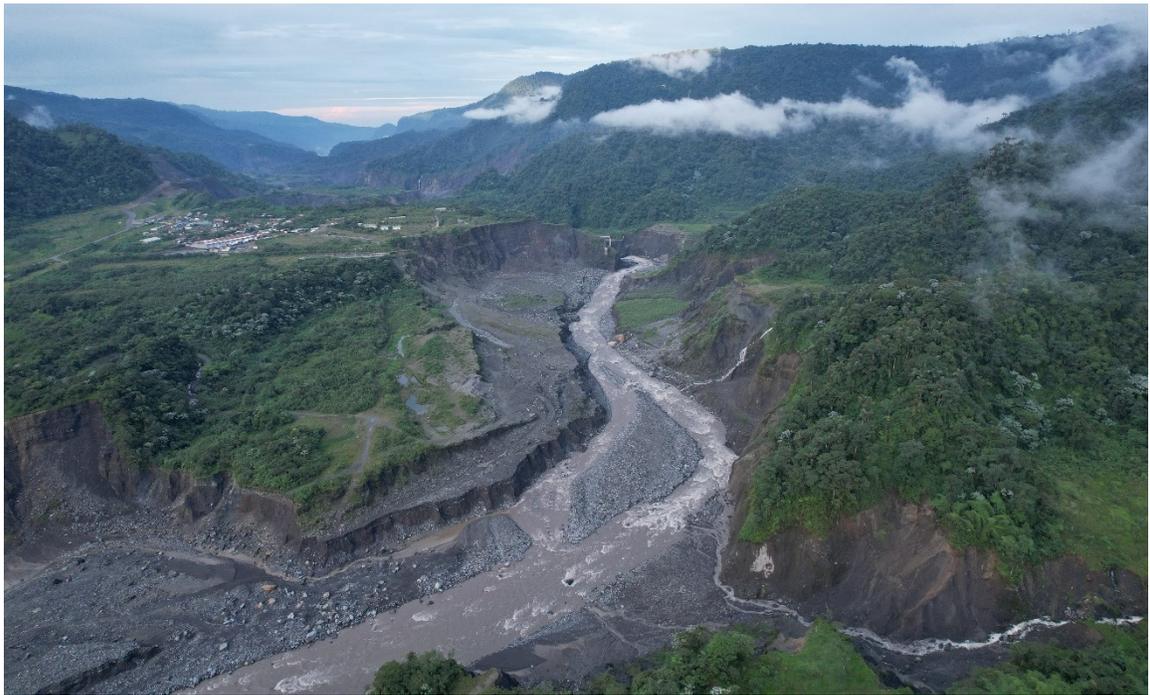
Figure 2. Looking upstream a the canyon formed by of the regressive erosion about 11 km upstream of the former lava dam site (Feb 2023).

Other papers in this conference, (Barrera, 2023b) and most of the investigation surrounding this event, focus on the “acute” failure mode, and the regressive erosion upstream (Figure 2). But the downstream deposition presents a “chronic” failure mode that could take longer to unfold and have longer-term effects (Gibson et al, 2021). In addition to the powerplant impacts, the downstream sediment pulse may impact infrastructure and ecosystems downstream.

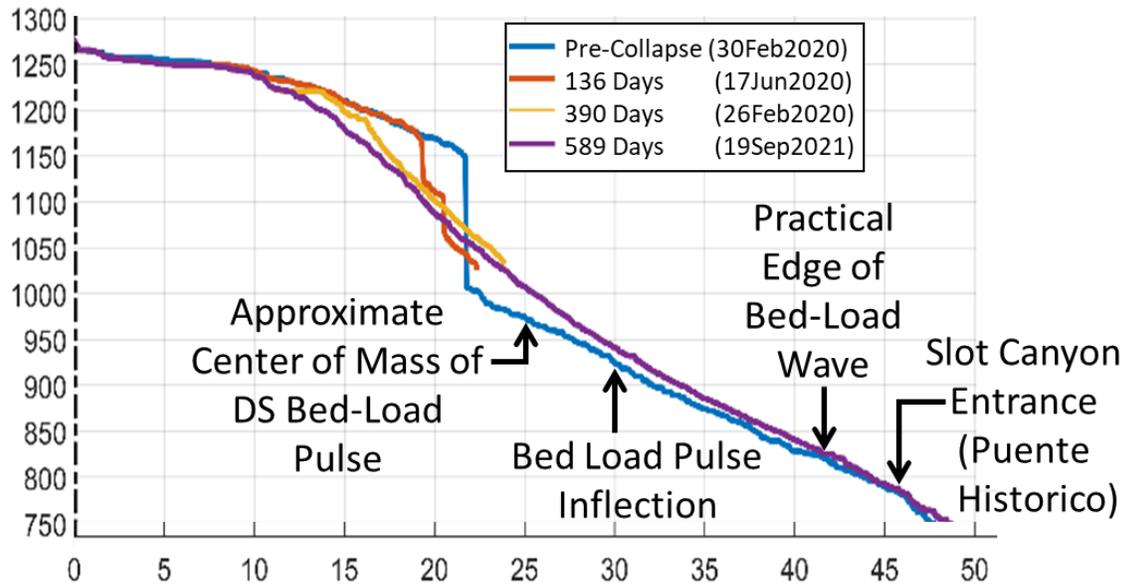
Figure 4 includes river bed profiles collected prior to the lava dam collapse and 20 months after the collapse. As of September 2021, the center of mass of the bed material pulse advanced approximately three kilometers downstream, where the new bed elevations were more than 20 m above the original grade. This sediment pulse tapered downstream for about 20 km. Figures 5 and 6 includes images of the deposition 7 km downstream of the lava dam site (close to the inflection point in Figure 4), about 15 months after the initial lava dam failure.

The regressive erosion supplied enough sediment that the deposition zone extends upstream of the former lava dam location. The post-collapse surveys from Figure 4 measured more than 40 m of deposition at, and upstream of, the former lava dam location. The phases of deposition and erosion in this dynamic reach of the system likely follow Schumm's (1977) complex response model, responding to supply pulses from episodic erosion, and a series of head-cutting and widening events along the river and tributaries. Discrete observations of reach behavior may represent temporary or transient responses to recent, complex response episodes.

Figure 4. Bed profiles collected at three intervals after piping failure undermined the lava dam, including a downstream profile collected 20 months after the event. Three different measures of bedload progression are labeled on this profile with the location of the slot canons (Puente Historico). Modified from Barrara (2023a).

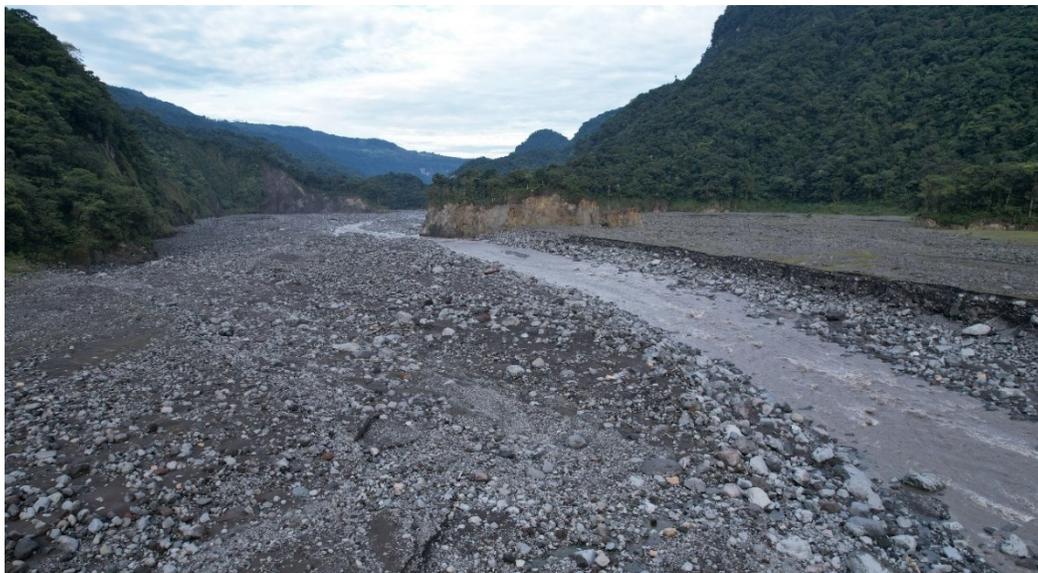
However, the sediment delivery from the regressive erosion has decreased. The river is beginning incise into these initial around the lava dam location as the supply decreases relative to the locally over-steepened slope, which initially formed by the peak sediment load from the highest-gradient erosion through the highly erodible volcanoclastic avalanche material that composed most of the eroding material in the first 10-km upstream of the waterfall site.

Figure 7. Photograph of the river bed taken at the same location as the areal photograph in the previous figure (the bedrock “island” is visible in both (Feb, 2023)). This reach still has the valley-wall-to-valley-wall deposition from the initial sediment pulse but has recently begun to incise into those deposits.

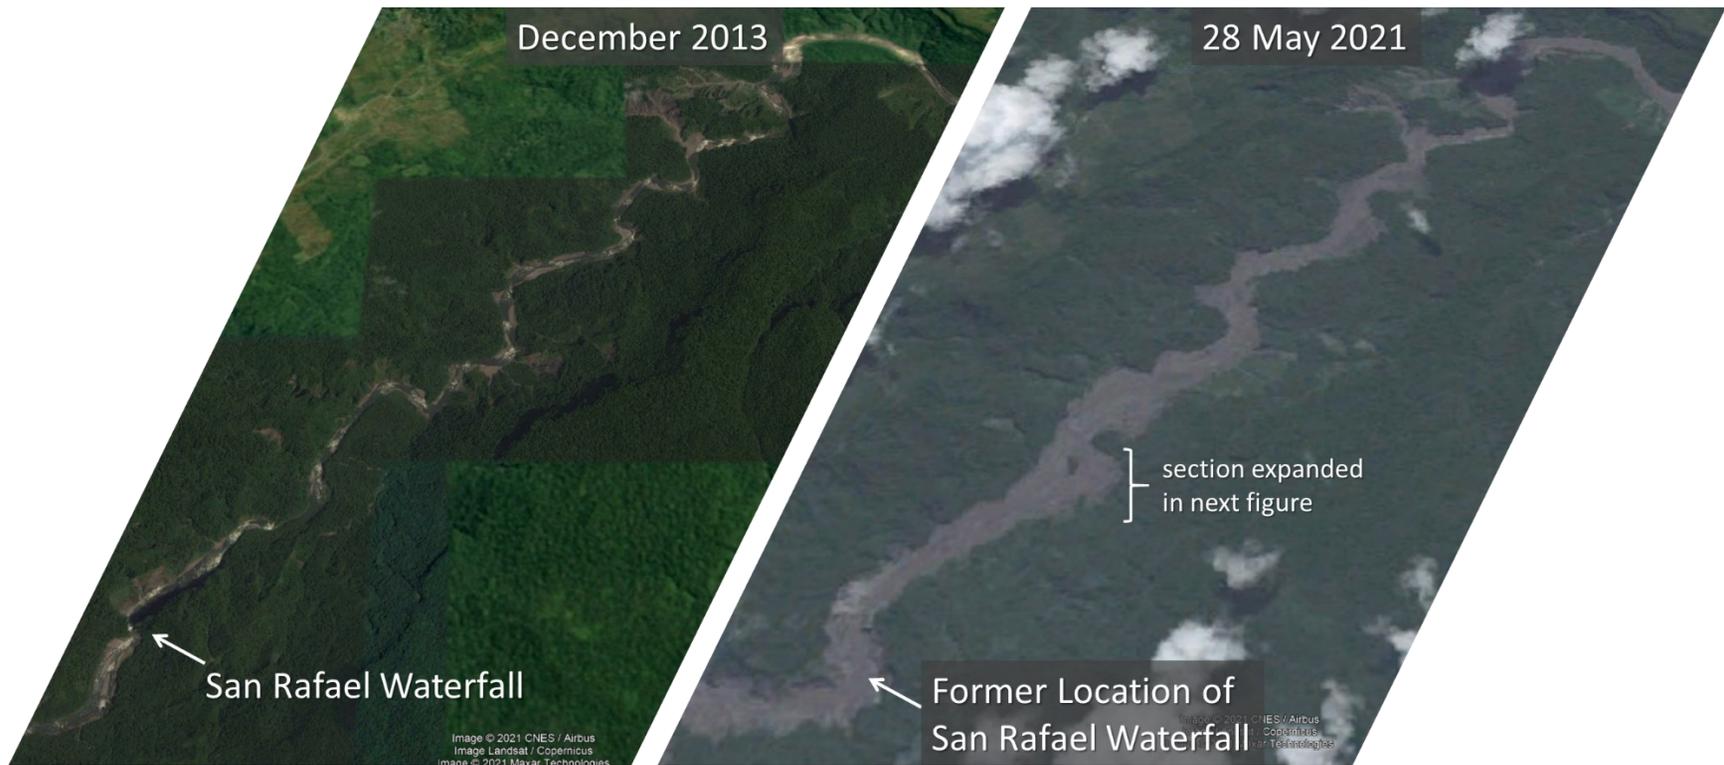
Figure 5. Approximately seven kilometers downstream of the San Rafael waterfall site before (2013) and after (May 2021) the collapse. The image on the right provides some insight on the scale of deposition downstream of the dam and the center of mass of the downstream sediment that must transport past the outlet structure. (May 2021, photographs from the Unclassified Digital Globe database which USACE requested access to for this project). The next figure zooms in on the indicated section from the post-collapse image.

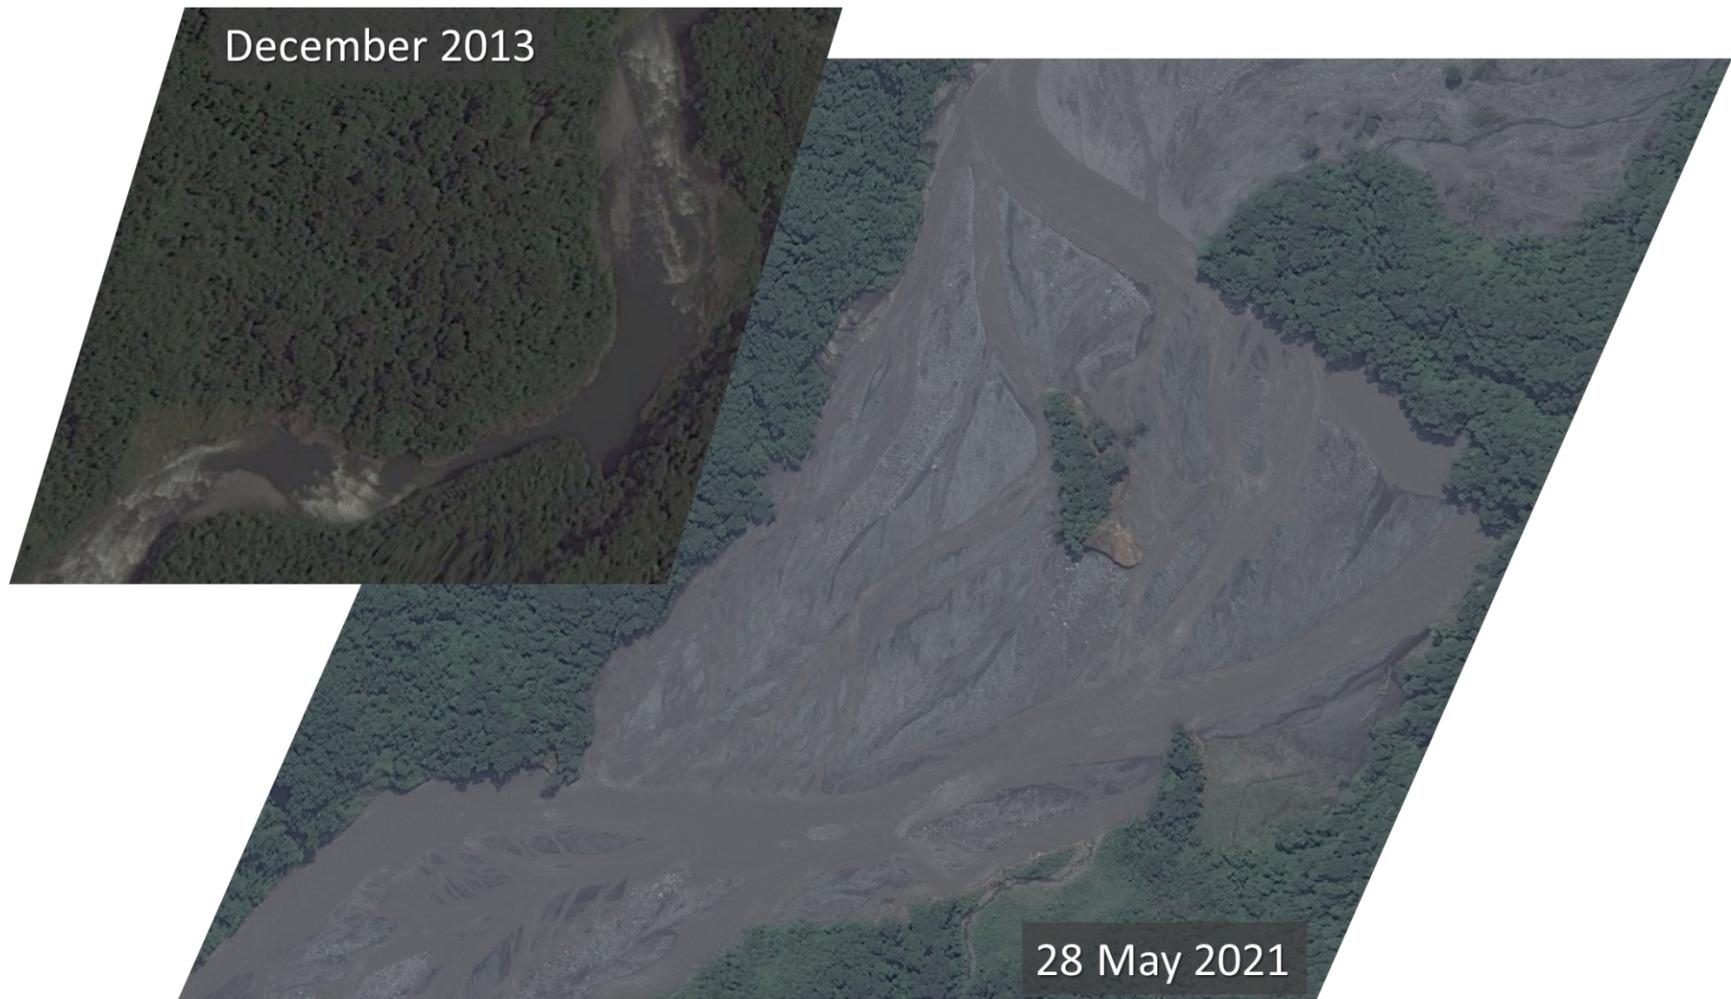
Figure 6. Imagery from one river bend (location indicated in previous figure) about one kilometer downstream of the former site of the San Rafael lava dam before and after the collapse (from Gibson *et al*, 2021).

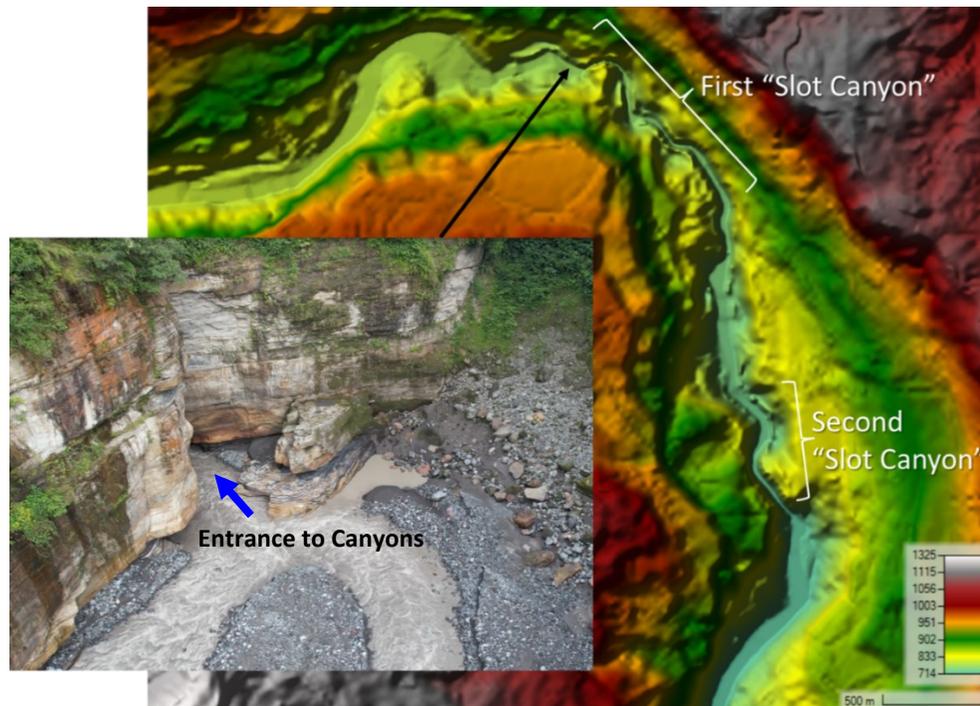
The Rio Coca also includes narrow bedrock canyons in this downstream-deposition reach that complicate predictions of the downstream fate and timeline of this sediment pulse. About 25 kilometers downstream of the former lava dam site, not far downstream of the downstream edge of the bed material load pulse, the river transitions into a reach of narrow, bedrock, slot canyons (location indicated in Figures 1 and 4). The entrance to these slot canyons is a substantial flow constriction (Figure 8).

Figure 8. Topography of the slot-canyon reach downstream of the bed load pulse and the flow constriction at the entrance to these features.

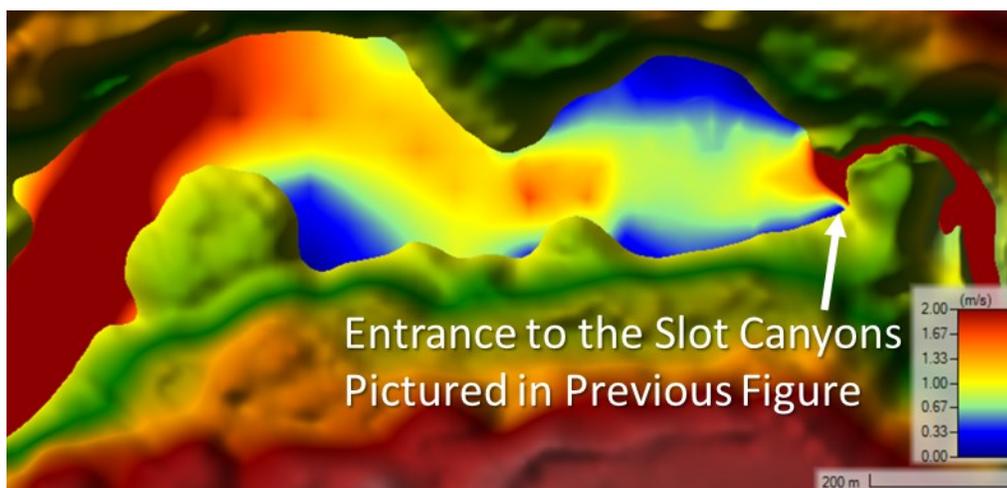
Hydraulic modeling confirms a substantial backwater (and slower flow velocities) upstream of narrow bedrock canyons (Figure 9). Sediment transport capacity of the bed-material load grain classes has in inverse relationship with flow through these backwaters. At higher flows, backwater effects extend farther upstream, decreasing transport capacity. This feature will trap bed material. The backwater “reservoir” upstream of the slot canyons only represents about 4 million m^3 , which is a small fraction of the bed material pulse. However, it could affect, and possibly attenuate, the arrival of the cobble-boulder pulse.

Figure 9. Velocity results from an HEC-RAS 2D model of the reach directly upstream of the slot canyons ($4,000 m^3/s$). Large flows form a backwater reservoir upstream of the bedrock constrictions which will slow the downstream progression of the bed material pulse.

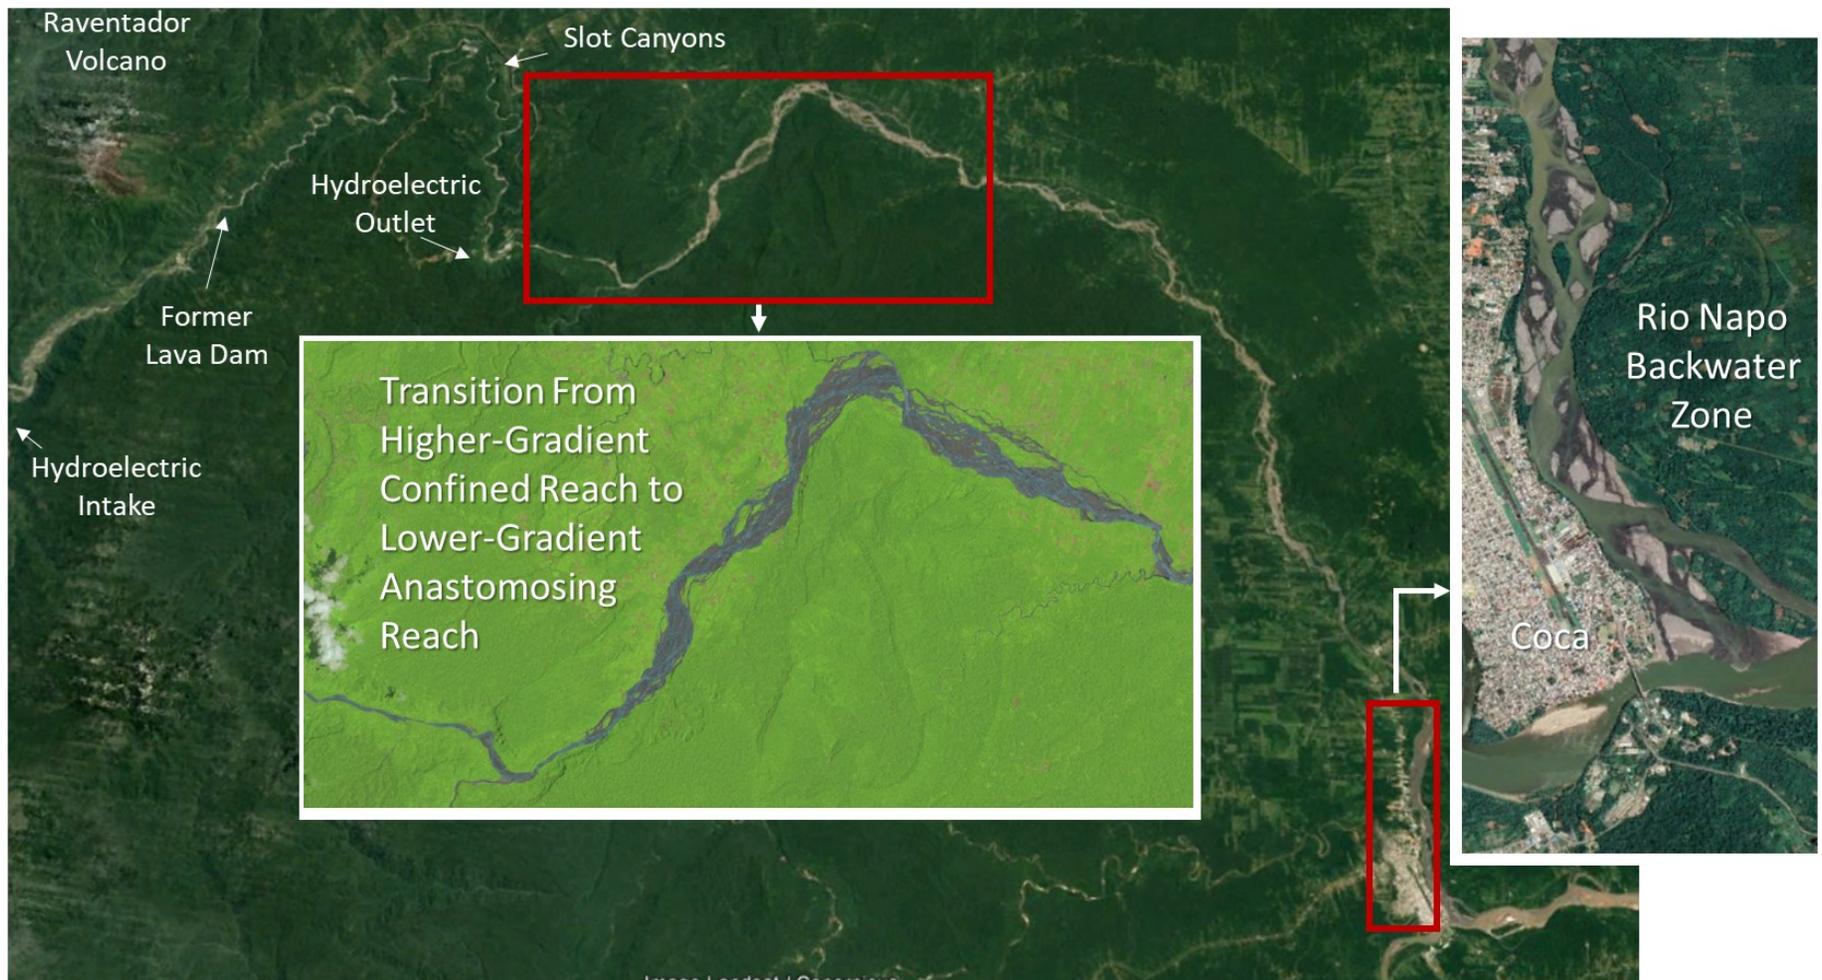
In addition to increased turbidity, downstream impacts are likely where slope changes shift the coarser wash load grain classes to bed-material load. About 70 km downstream of the former lava dam site, the Rio Coca emerges from the confined channel into a lower gradient, anastomosing reach (Figure 10). This lower-gradient anastomosing reach (with slope 0.003, compared to the 0.009 throughout the reach from 0 to 70 km discussed above) already exhibits signs of aggradation. Coarser sand grain classes that transport through the steeper, confined reach, past the hydroelectric outlet, will transition to bed material load in this reach and deposit, potentially increasing the flood risk for communities along this reach.

Additionally, the backwater influence (Figure 10) of the Rio Napo extends through the largest city in the region (Coca). This backwater zone will decrease capacity again, and additional sand sizes will transition to bed-material load, potentially depositing through the urban reach and affecting flood risk.

Figure 10. Downstream locations with sediment deposition potential. At capacity transitions, sand grain classes that transported as wash load in the confined, higher gradient reach can transition to bed material load and deposit, inducing flood risk. Inset image from Sentinel-2, background image from Google Earth.
