DRAFT- Lessons Learned from Bank Stabilization Failures

Chris Haring, PhD, P.G., Research Physical Scientist, Coastal Hydraulic Laboratory, Engineering Research and Development Center, U.S. Army Corps of Engineers, Vicksburg, MS.
christopher.p.haring@usace.army.mil

John Shelley, PhD, P.E., Senior Hydraulic Engineer, River Engineering and Restoration Section, United States Army Corps of Engineers, Kansas City, Missouri,
John.Shelley@usace.army.mil

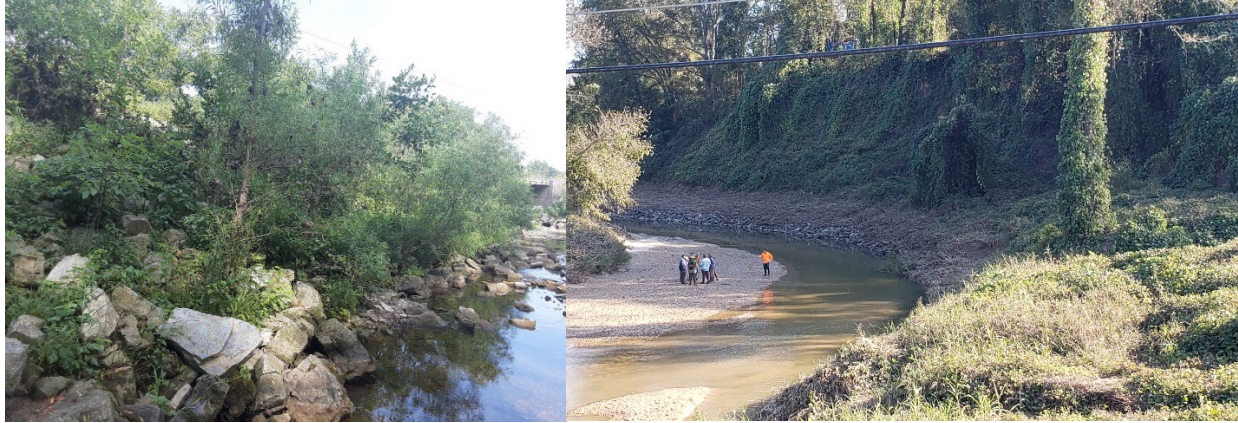
deposits) and aesthetic (reduction in visible hard stabilization methods) benefits than the standard WBRR (Haring et al., 2021). If WBRR projects are not maintained, vegetation often develops within the revetment adding to the benefits described (Figure 1, left). However, in some regions invasive species may become dominant such as kudzo, providing little or no ecological or stabilization benefits (Figure 1, right).

Figure 1. (Left) A whole bank riprap revetment in process of vegetative colonization. Wolf Creek, Missouri. (Right) A whole bank riprap revetment colonized by invasive kudzo. Clear Creek, Mississippi.

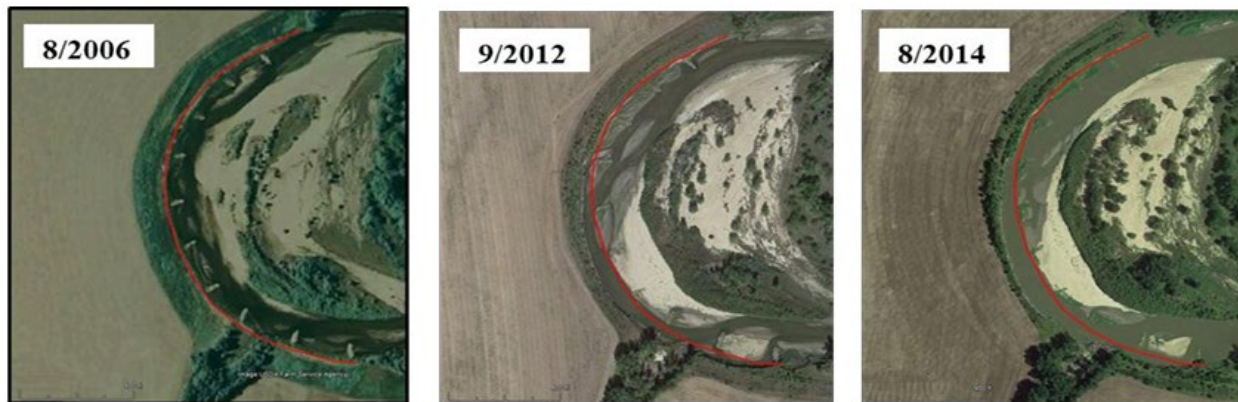
We have observed failure by flanking with virtually every type of redirective stabilization technique. This is especially problematic in redirective techniques such as bendway weirs, barbs, or vanes, as these structures can actually accelerate erosion rate at the structure/bank interface. The rock vanes built on the Republican River upstream from Milford Lake offers a clear example. Within the first 6 years, the most downstream 6 out of 10 total vanes had been flanked. Other the next 2 years, the river flanked the remaining four structures.

Figure 2. Flanking of rock vanes on the Republican River, KS failed multiple structures within 6 years and all the structures within 8 years. Flow is from top to bottom. From Williams and Shelley (2020).

Flanking can be minimized by extending the protection to stable positions upstream and downstream, and keying in structures to the bank.

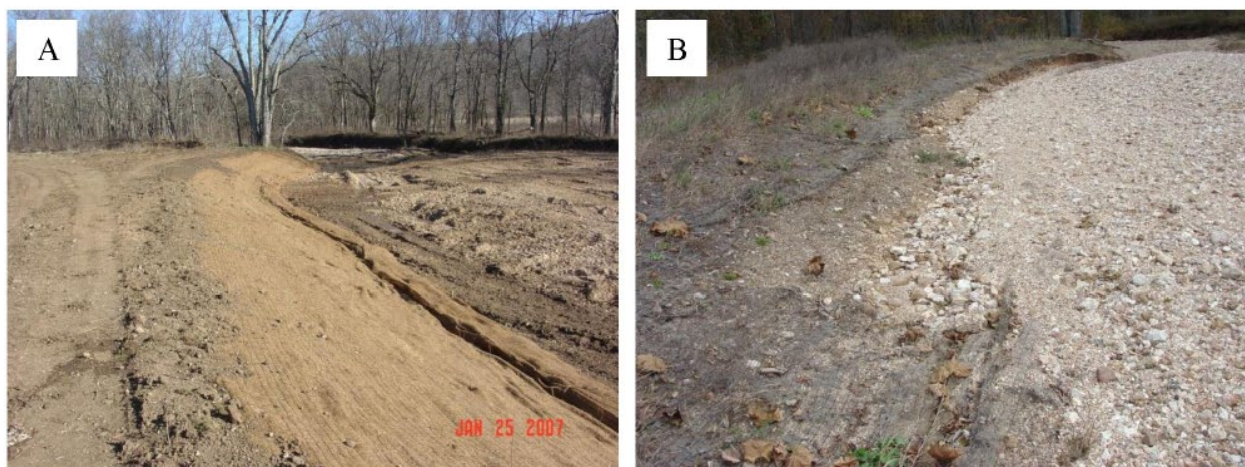
Non-launchable protection can fail even more catastrophically. The Missouri Department of Conservation, installed an experimental “gravel roll” in conjunction with bank sloping and vegetation plantings on Mill Creek in the Missouri Ozarks. The gravel roll was built by placing erosion control fabric at the toe of the streambank, backfilling with gravel, rolling over the fabric, and sewing it together. The gravel roll was intended to stabilize the toe while the bank sloping and plantings provided long-term stability. Instead, the gravel roll failed during the first out of bank event, which occurred that same year. Persinger et al. (2007) report the failure occurred because the gravel roll did not launch and adjust to scour the way riprap does. Rather, it acted as a single long tube. Moreover, the gravel roll did not protect a sufficient vertical percentage of the riverbank, which allowed mid and upper bank erosion and flanking.

Figure 3. (A) A newly gravel roll installed at the toe of the bank of Mill Creek, MO on January 2007. (B) Same site, post failure, November 2007. From Persinger et al. (2007).

To compensate, some many practitioners will either trench in their structures or else make them extra wide and long to account for the launching. Wood structures can be built on a launchable rock toe.

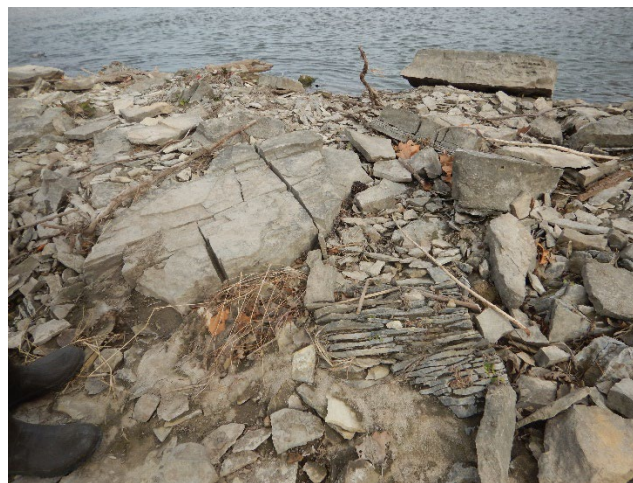
Rock fragmentation and disintegration can also lead to smaller rock sizes that fail prematurely (Figure 4). Rock blasting can induce microfractures that speed disintegration.

Figure 4. Rock weathering and disintegration in a structure on the Republican River, KS.

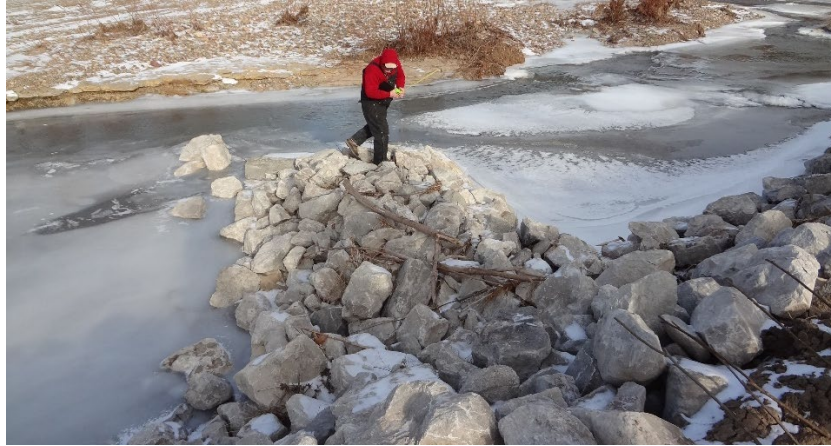
Insufficient rock size can also occur due to construction error. On the Missouri HWY 617 project, a single moderate flow event caused bendway weirs to lose a significant percentage of their length one month after construction (Figure 5). On investigation, we found that the rocks had sorted during construction, such that all the large rocks were in a few weirs and all the small rocks in other weirs. To compound the issue, the point bar opposite of the weirs contained layers of bedrock. Unsurprisingly, the weirs with the smaller rocks were washing away.

Figure 5. Rock was too small in this bendway weir near Missouri HWY 617. Rock is washing away from a single, moderate flow event. January 2012.

This site was repaired by encapsulating the weirs with larger, well-graded rock. At last inspection the project was functioning properly.

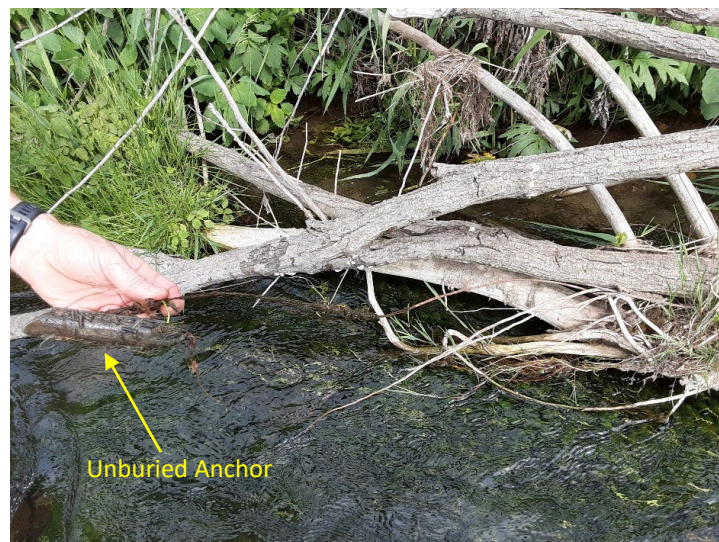
On Riceford Creek in Minnesota, high flows eroded the bank above and then behind the cedar tree toe revetment (Figure 6). Erosion proceeded far enough to unbury the anchors. The next high flow event is likely to dislodge these trees completely.

Figure 6. Flanking of a cedar tree revetment on Riceford Creek, MN has eroded so far that the anchor is no longer buried and water flows behind the tree.
