'Stage Zero' Restoration of Whychus Creek, Oregon: Monitoring Results and Lessons Learned

Extended Abstract

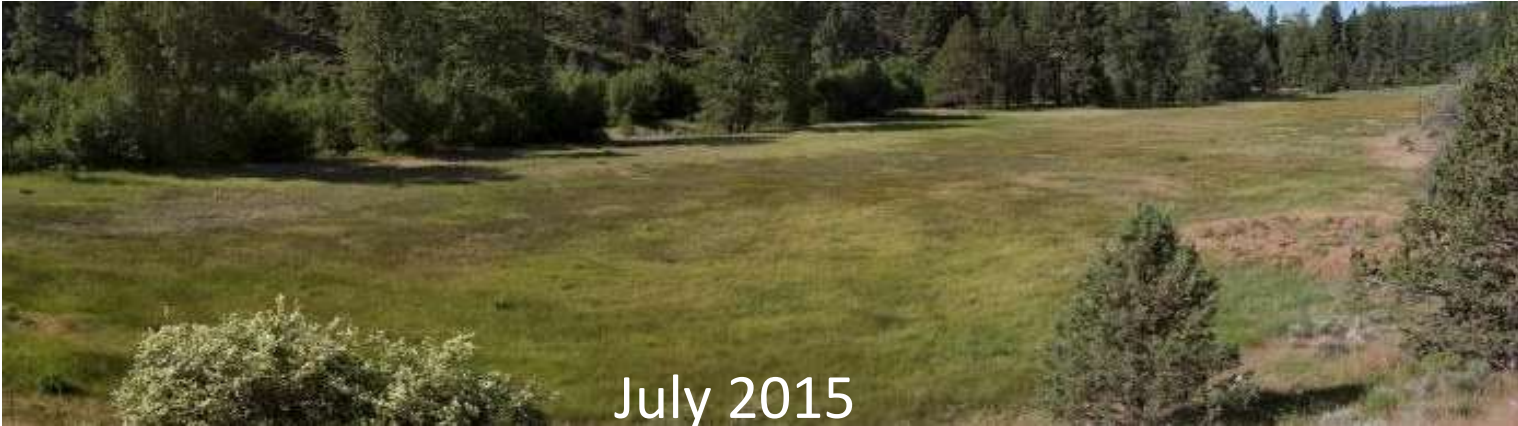
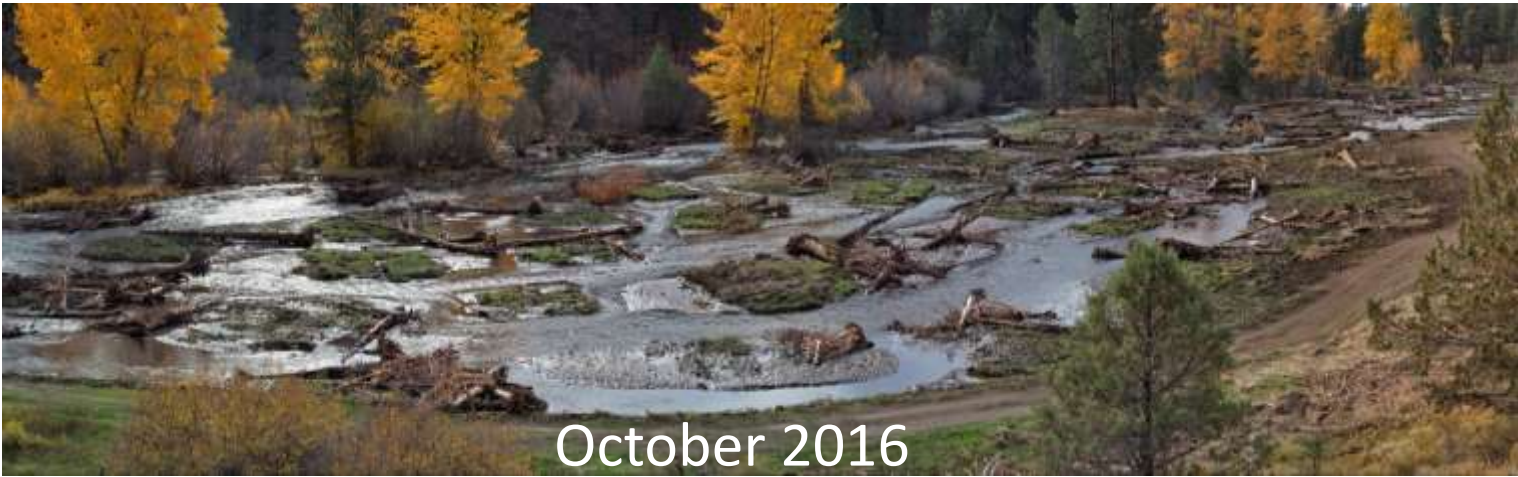
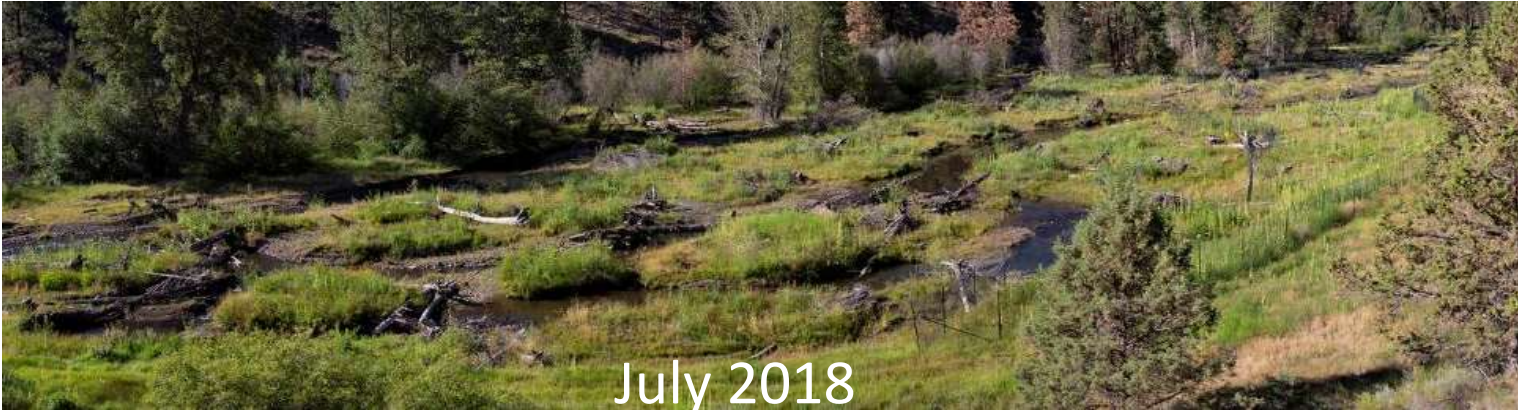
Figure 2. Project Implementation (pre-restoration (2015), immediately post-construction (2016) and 2-years post-construction (2018)).

The pre-restoration, single-threaded, statically-stable channel was incised below the historical floodplain by about 10 feet. It had been relocated along the valley-right toe slope and in Figure 2 it is marked by a line of trees on the far side of the valley floor in the upper photograph. Restoration involved filling-in the incised channel and lowering the valley floor in places, to fully reconnect the stream and its floodplain. Immediately following these actions multiple, dynamically-adjusting anabranches developed (see center photograph in Figure 2). Within 2 years, the post-restoration, braided system had evolved and vegetated into an anastomosing planform, as shown in the lower photograph in Figure 2. This transformation led to very large increases in instream habitat quantity and complexity, with a 187% increase in wetted area at base flow, a 443 % increase in the number of habitat units, and a 429% increase in number of pools. Sediment sampling has revealed a reduction in the percentages of cobbles and boulders (which constituted most of the channel substrate prior to restoration) and increases in the percentages of gravel, sand and silt.

A broader lesson learned is that the complexity and valley wall to valley wall extent of fully-connected channel-wetland-floodplain systems created by restoration to 'Stage 0' (see Figure 2) is difficult to adequately describe using conventional, channel-centric, and ground-based monitoring methods. At Whychus Creek, UDWC is expanding the scope of monitoring to capture novel parameters such as 'patch complexity' and, in judging success, we are coming to rely on measures of diversity and variability as much as on traditionally used measures of central tendency. In short, we are interested in parameter ranges and standard deviations as well as spatially- or time-averaged mean, median or modal values.
