# Post-wildfire sediment transport modeling versus field observations: Northern Arizona case studies

## Abstract

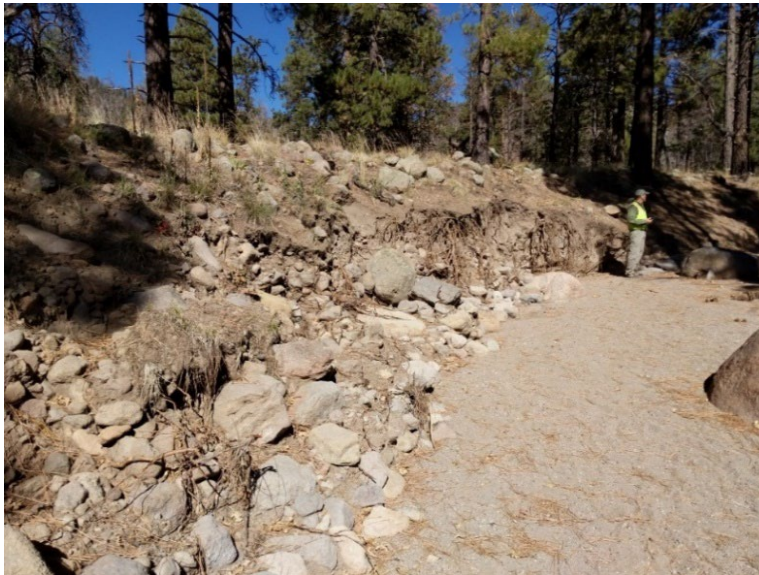
**Figure 2. Natural Channel Design LLC staff completing the BEHI analysis at a typical channel cross-section in Spruce Wash.**

*BEHI data collection-* Bank erosion hazard index (BEHI) surveys were used to qualitatively evaluate all eroding channels within the Spruce Wash watershed, (Rosgen 2002; Figure 2). During BEHI surveys, data was collected by teams of two field staff on tablets, this enabled the user to rapidly tabulate and georeference all field data on pre-formatted field forms. Collected data consists of channel bank height (left and right bank), channel and bank material, length of channel, vegetation and root density, bank slope angle (left and right), valley and stream type classification (Rosgen 1996), and near bank stress (NBS). Collected field data was manually checked for quality assurance and control using ESRI ArcGIS geospatial software.

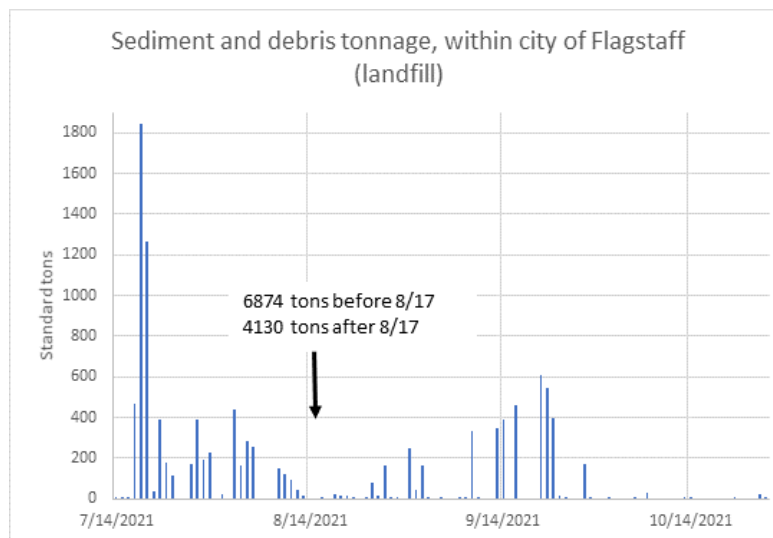
**Figure 8. Sediment and debris tonnage removed from channels and streets. Flood events occurred on July 13, 14, 16, and August 17th. Flood flows were predicted at the upstream entry to the CoF as 700, 700, 1000, and 1580 CFS respectively.**

A simplification of the 2021 rain events would provide a MUSLE sediment yield estimate of 5400 tons (three 1 inch rain events in July and one 2 inch rain event in August; all medium K values). Empirical results from in-city sediment removal, as measured at the Cinder Hills Landfill, are provided in Figure 8.

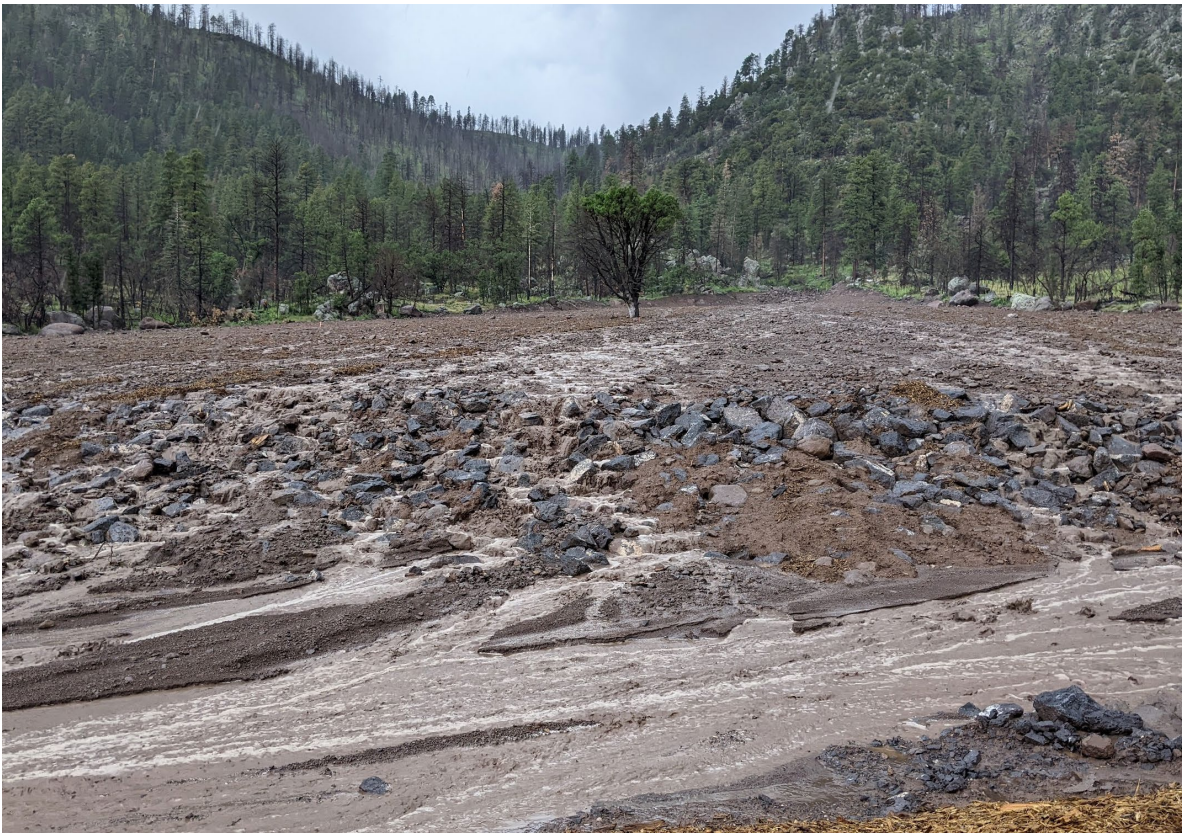
**Figure 9. Ginger alluvial fan work site (looking upstream) during a 2022 flow event, note the spread of flow and subsequent drop in water velocity allowing sediment aggradation.**
