# **Reconnaissance of the Rio Coca Regressive Erosion and Building the Partnership**

## **Abstract**

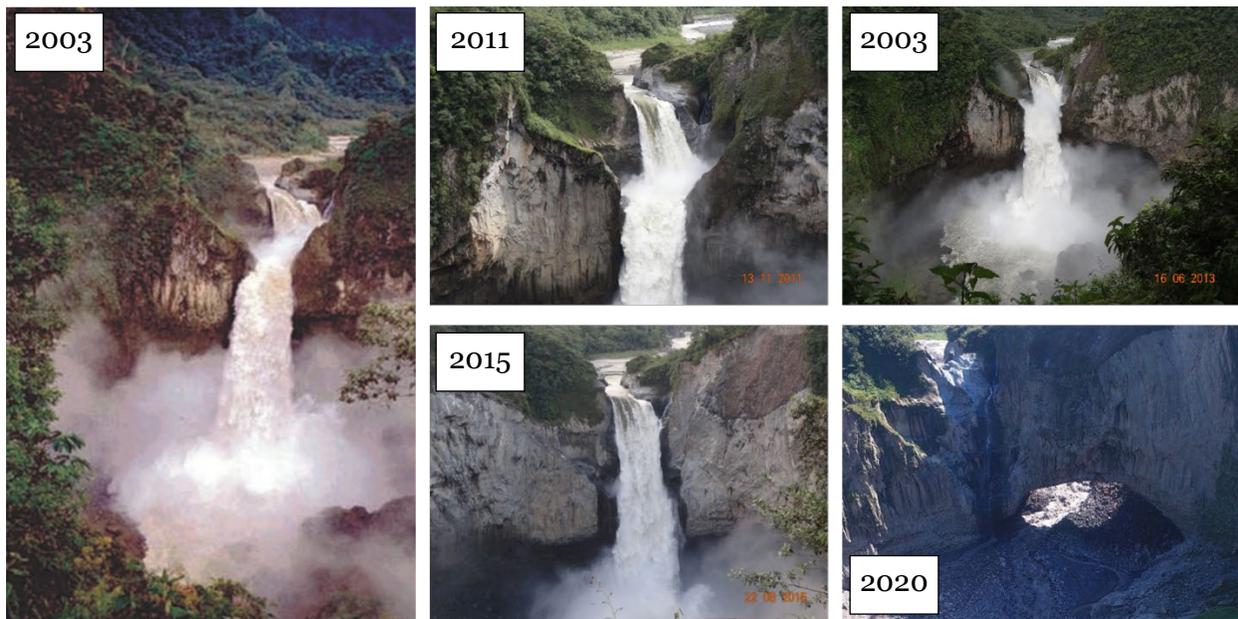
On February 2, 2020 the San Rafael waterfall on the Coca River in northern Ecuador failed catastrophically through a series of erosion processes including knickpoint erosion followed by a piping failure (see Figure 1 for a progression of the failure). The failure of the lava dam released over 200 million cubic meters of volcanic sediment downstream and resulted in a headcut that began to propagate upstream. Soon after the waterfall collapse, numerous oil pipelines, bridges, and structures failed as the regressive erosion propagated upstream in the valley. As of September 2021, the headcut has advanced approximately 11.1 km upstream and is only 7.9 km downstream from the intake structure associated with the Coca Codo Sinclair (CCS) hydropower complex – the largest hydropower facility in Ecuador. Additional description and context of the regressive erosion and overview of the event is described in Espinoza and Boyd (2023).

**Figure 1.** Evolution of the San Rafael Waterfall Failure from 2003 through 2020

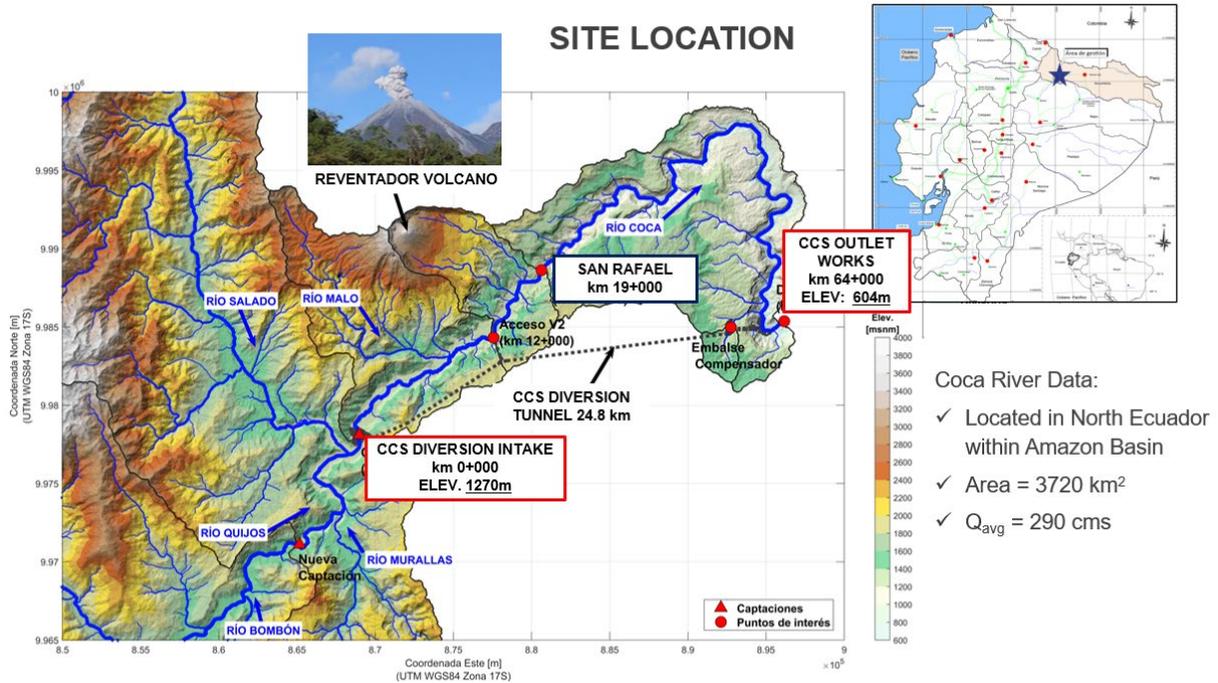
A site location and details of key site features is shown in Figure 2. The Coca River flows to the northeast at the former San Rafael waterfall location (Station 19+000 km). The Coca Codo Sinclair (CCS) diversion intake is located 19km upstream of the former San Rafael waterfall, and the Outlet works of the CCS discharge at a location 45km downstream of the former San Rafael waterfall. The Reventador Volcano (the source of the lava dam that created the San Rafael waterfall) is located to the northwest of the former San Rafael site.

**Figure 2.** Site Location and Key Site Features.

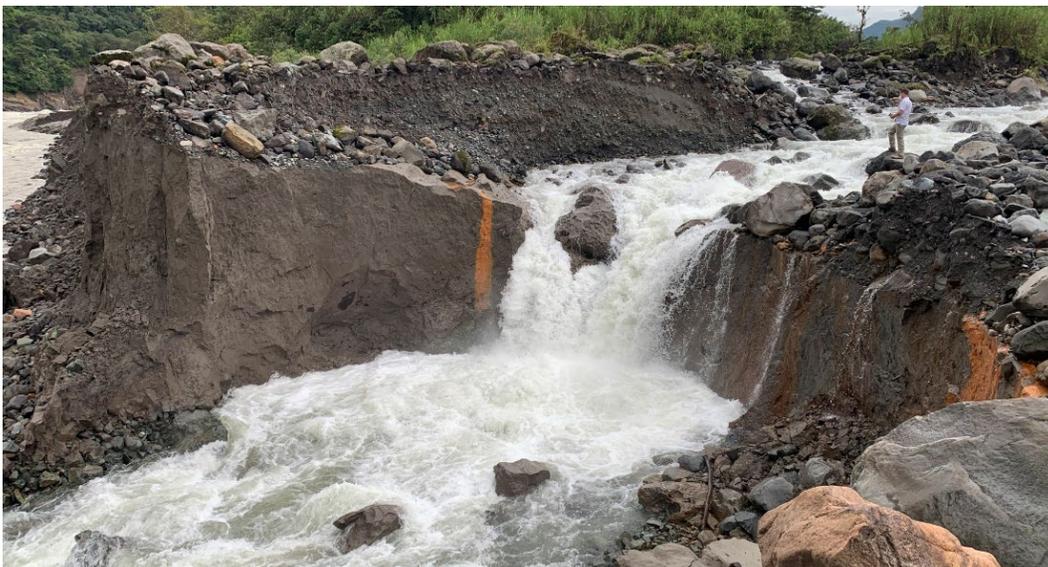
**Figure 3.** The headcut at the mouth of the Río Malo (which developed mostly during the July 19, 2021 event) illustrating the conceptual model of the plunge pool driving the lacustrine headcut.

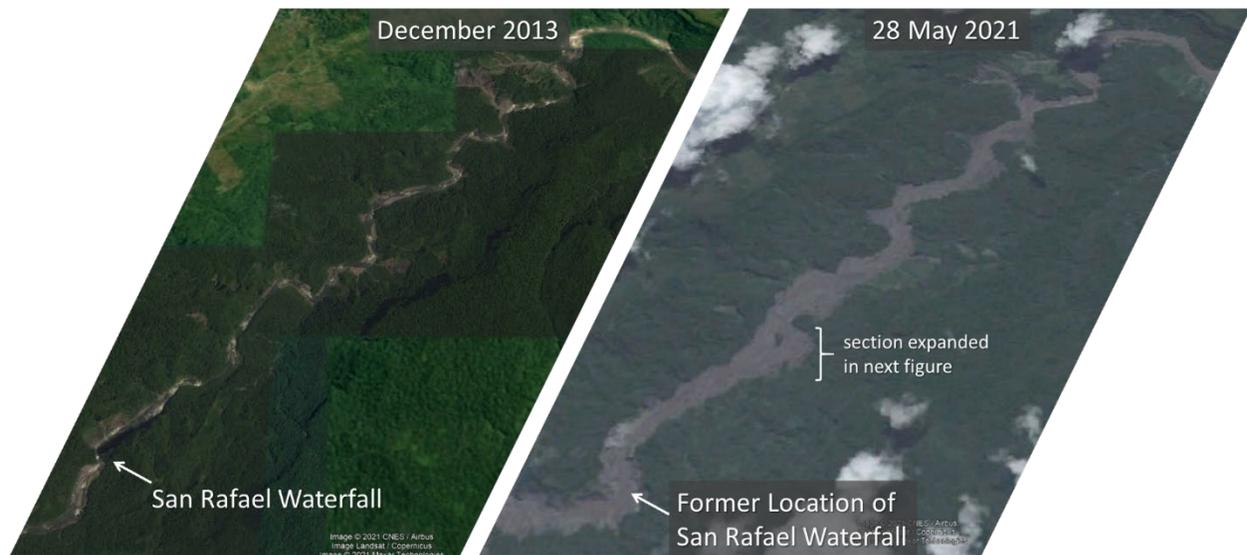
Most analysis and studies to date have focused more attention and effort on the upstream failure mode, but the downstream process – progressive deposition –also threatens the hydropower project capacity and, eventually, failure. Figure 4 and Figure 5 show the progressive deposition 7 km downstream of the site of the lava dam, about 15 months after the initial lava dam failure. The center of mass of the sediment-wave is still in this reach. The sediment-wave will move downstream as a slow moving sedigraph. The bed elevation at the CCS outlet structure will raise as the center of mass approaches. Near the former San Rafael waterfall there has been deposition of approximately 40m. The maximum deposition will attenuate downstream, so the deposition at the outlet will be less than the 40 m at the former San Rafael waterfall. However, it will be more than the initial 2m observed after the July 2021 event.

**Figure 4.** Approximately seven kilometers downstream of the San Rafael waterfall site before (2013) and after (May 2021) the collapse. The image on the right provides some insight on the scale of deposition downstream of the dam and the center of mass of the downstream sediment that must transport past the outlet structure. (May 2021, photographs from the Unclassified Digital Globe database).

The USACE team recommended that CELEC form a team to forecast the timing and magnitude of the sand wave at the CCS outlet structure (and other critical downstream infrastructure). A regional sediment model could route the sediment wave downstream and distinguish between the representative possible future scenarios illustrated in the conceptual model in Figure 6. This downstream study will have a larger model domain and will run for multiple years (or decades). A simplified one-dimensional model would likely be sufficient to address initial operational questions downstream.

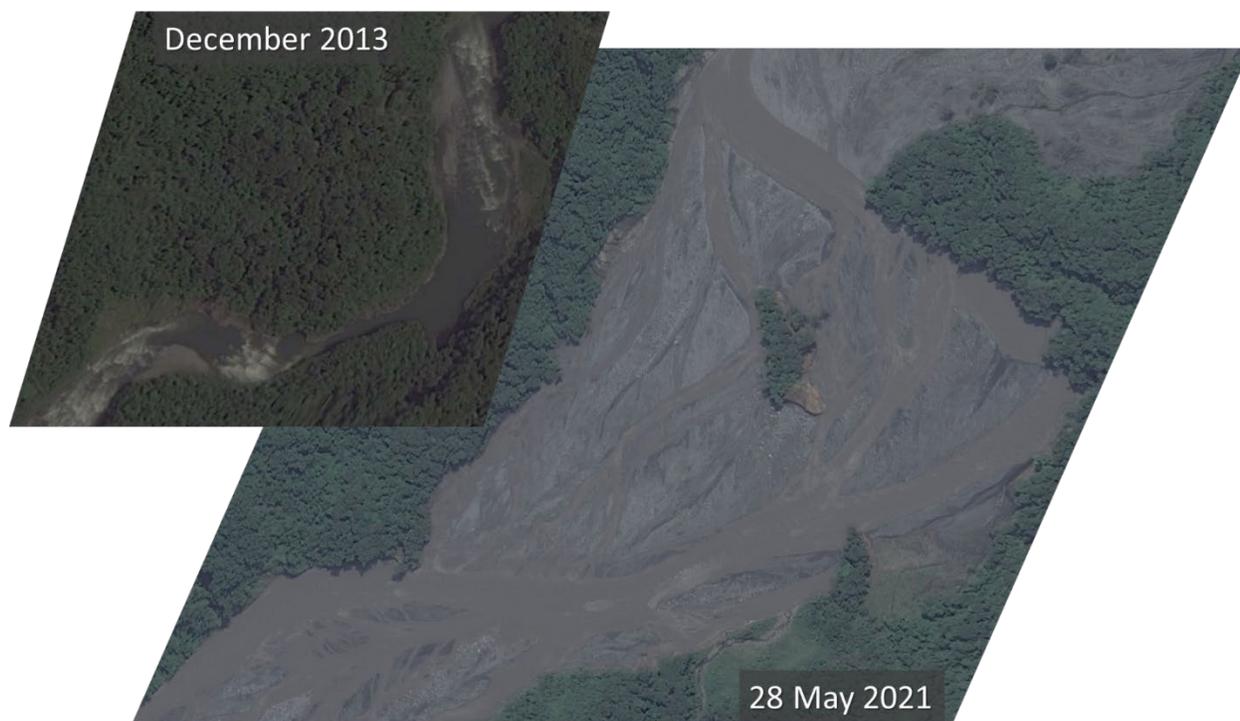
**Figure 5.** Imagery from one river bend (location indicated in previous figure) about one kilometer downstream of the former site of the San Rafael dam before and after the collapse.

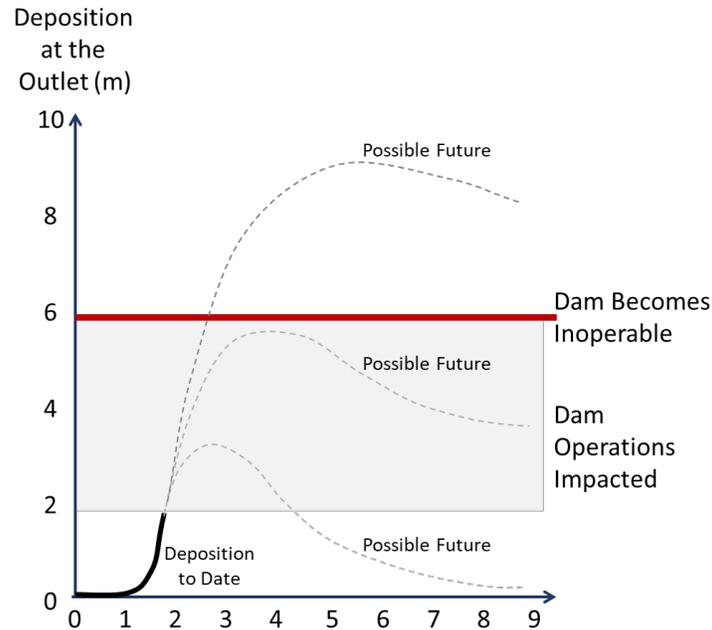
**Figure 6.** Schematic of the deposition at the downstream outlet (KM65). The black line is the deposition to date (total = 2m) and the dotted lines represent several possible futures. The dam becomes inoperable at 6m and will have to go offline more often as deposition increases.

**Short-Term Issues and Operations at the Downstream Outlet:** The left-bank deposition at the CCS outlet structure pushed the flow to the right side of the channel, scouring the right bank, removing riprap and undermining the outlet structure. CELEC plan to build hydraulic structures (groynes) to redirect flow away from the localized erosion is promising.

Dredging could temporarily reduce the hydraulic pressure on the CCS outlet structure. However, dredging is not a sustainable solution at this location. With 220 million tons in the system, dredging and disposal operations will quickly be overwhelmed. Additionally, it will not be sufficient to just dredge the immediate location of the structure to decrease water levels. CELEC would have to dredge a reach downstream to mitigate backwater effects from deposition downstream of the outlet.
