COCA RIVER REGRESSIVE EROSION PHENOMENON, CAUSES AND IMPACTS. OVERVIEW OF THE PROBLEM.

SEDHYD 2023, PAPER 269

EXTENDED ABSTRACT

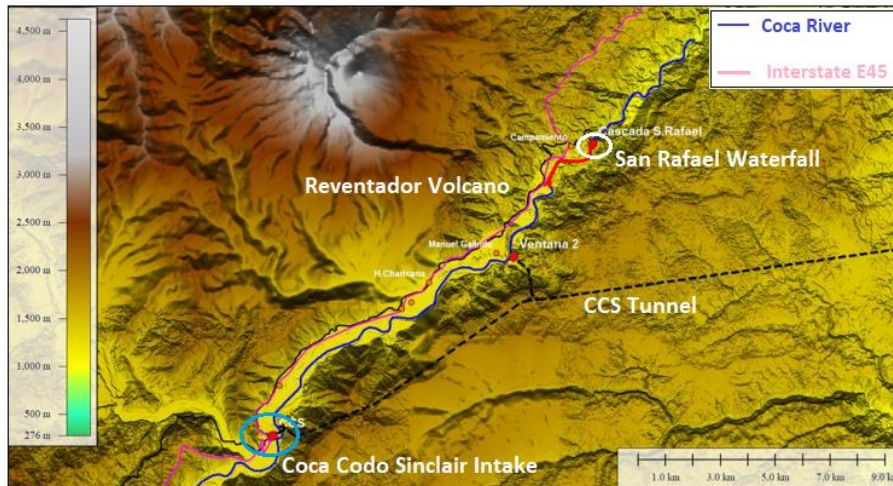
Figure 2: Reventador Volcano’s directly influence over the Coca River valley.

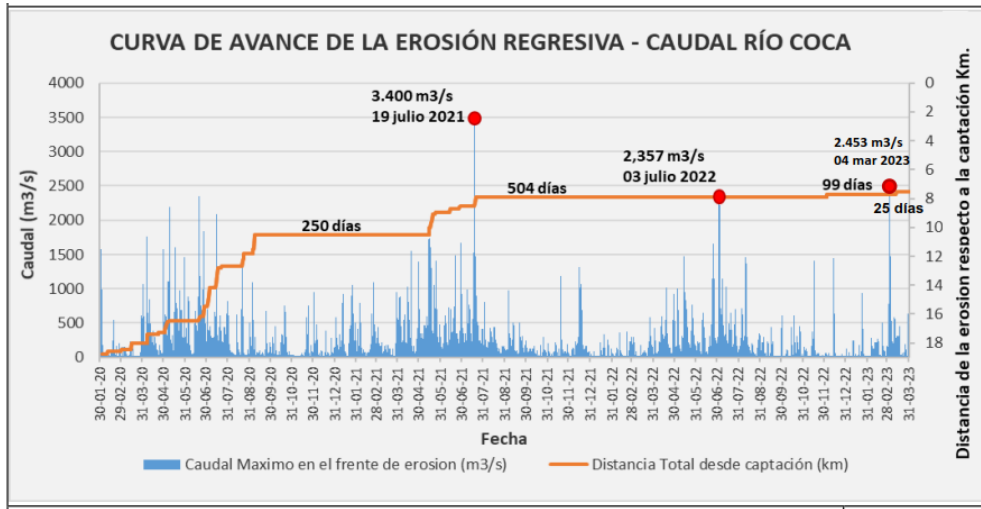
Figure 4: Erosion front evolution and daily maximum flows since February 2020.

The erosion front (headcut) as of April 8th, 2023 has advanced to 7+560 Km distance from the intake structure. The rate of advancement has varied since the waterfall collapse, for it depends on several factors, among them, the hardness of the riverbed materials, the width of the channel, and especially the flows. The greatest longitudinal migrations of the erosion front and deepening of the river correspond to events with more than 1,500 cms.

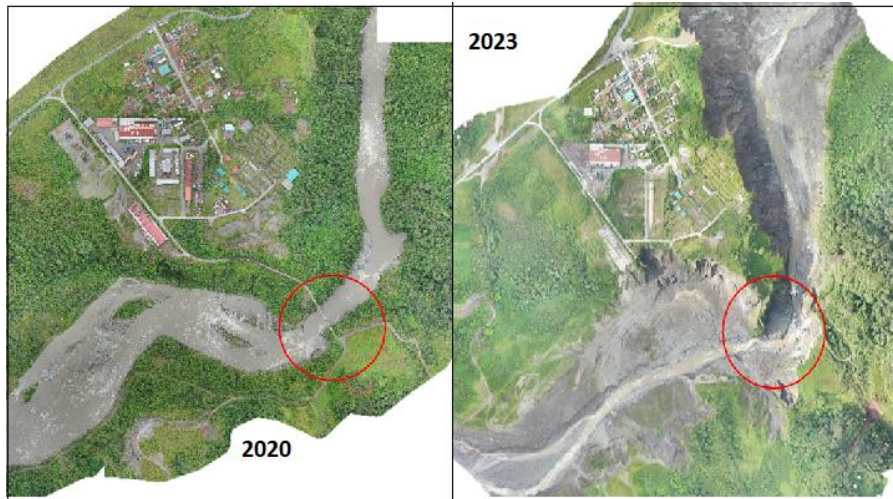
Figure 5: Photogrammetry of the Coca River. 2020 vs. 2023. San Luis Area, station 12+500. Shows 40+ meters of river channel degradation.
