Implementing Diverse Bank Stabilization Measures to Contain and Capture Lead-Contaminated Sediment

Joseph Collum, P.E., Civil Engineer (Hydraulics), U.S. Army Corps of Engineers, Saint Louis, MO, joseph.b.collum@usace.army.mil

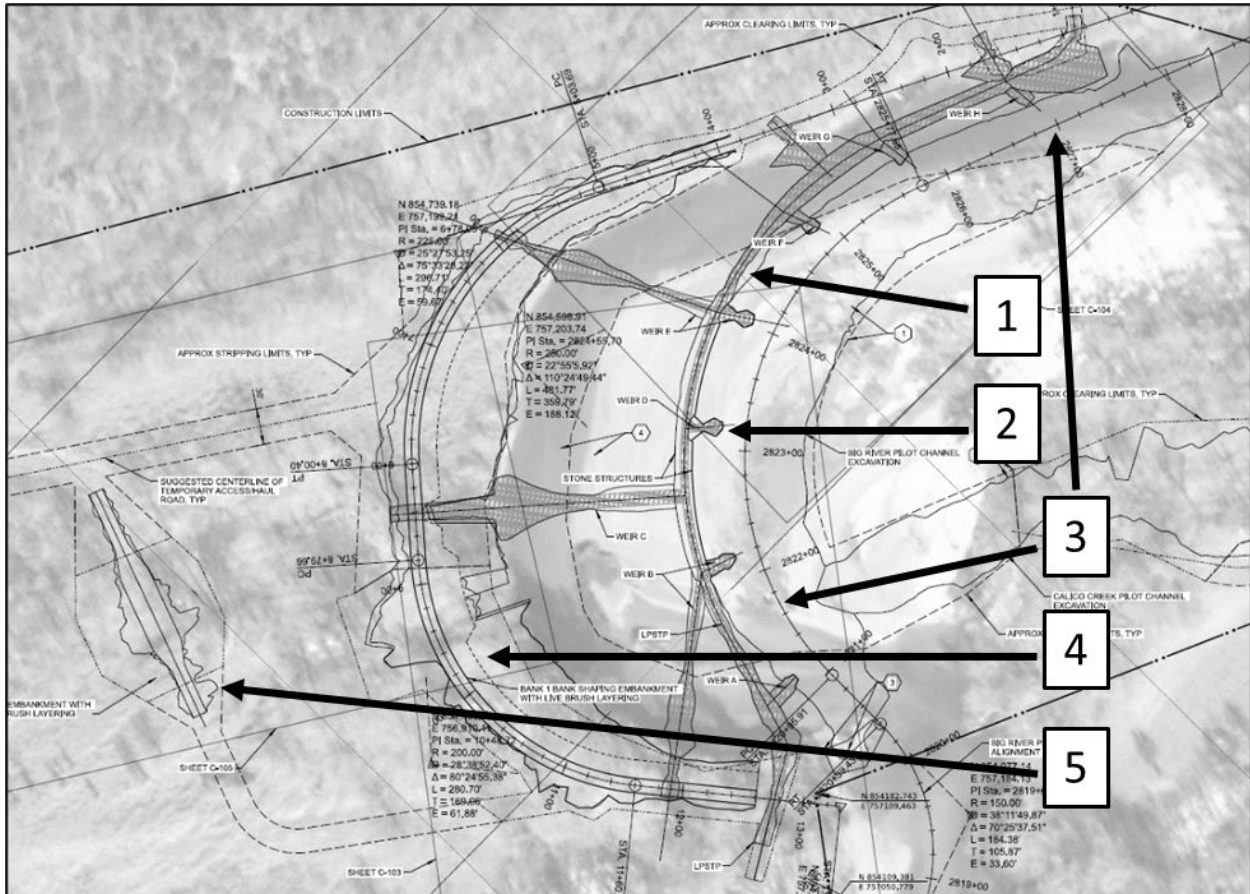
Figure 13. Bank 1 measures conceptual design plan view; flow from top right

This bank was experiencing a high rate of erosion prior to stabilization. Between 1996 and 2020, a substantial point bar grew from the LDB in the direction of the eroding bank. The planform of the river at this site had become highly sinuous during this timeframe (Figure 7), resulting in an inefficient flow path for the river. This condition provided an opportunity to realign the river to a more efficient flow path while providing overbank storage for landward deposition of suspended sediment from upstream.

Engineering judgement was central to the design of bank 1 (Figure 13). An idealized planform was developed in Google Earth, and then the LPSTP was laid out along that idealized line, along with regular tie-backs angled to direct flow downstream while mitigating the chance of flanking. The LPSTP was keyed into the banklines at either end.

3. Pilot Channel excavation through the existing point bar, on an alignment that provided the Big River with a smooth preferential path to take during its transition from existing condition to constructed condition. This pilot channel was also intended to improve the ease of construction of the other measures at this bank by reducing the “in the wet” work that the contractor would need to do.

4. Bank Shaping of the existing bankline to provide access to the above features during construction, and to establish a robust vegetative protection solution in subsequent years. In addition to simple sloping of the bankline, the top of the sloped bank was adjusted slightly to conform to a single, fixed elevation to allow for uniform overtopping during high flows that access the floodplain.

5. Floodplain check berm about 200 feet downstream of the crest of bank 1. This heavily vegetated soil check berm spans across the existing low floodplain channel (Figure 6). The berm was conceptualized to serve two primary purposes: the first is for site access across the low floodplain channel during construction and before planting vegetation; the second is to allow for flows that overtop bank 1 to dissipate in a contained pool between the berm and bank 1. The contained pool would fully backwater from downstream prior to receiving headwater flows and would drain into groundwater shortly after the recession of any flow condition that activates it.

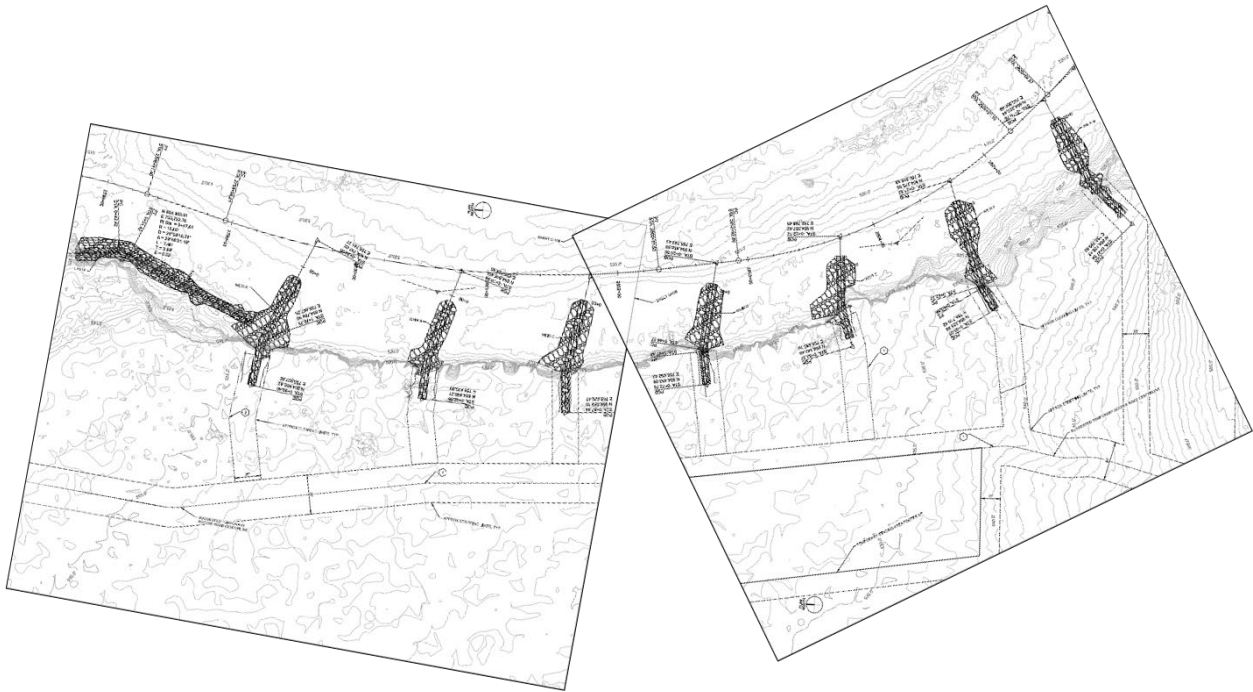
Figure 14. Bank 2 measures conceptual design plan view; flow from right

This bank was experiencing a moderate rate of erosion prior to stabilization. Between 1996 and 2020, a small point bar grew from the RDB in the direction of the eroding bank. The planform of the river at this site was becoming more concerning as the angle of attack into the bankline was beginning to sharpen as erosion progressed (Figure 9). This warranted a protective measure to stop the erosion. The landowner at this bank was not interested in providing any additional land for conversion to permanent riparian zone, so only measures that minimized permanent impact to their floodplain land could be considered. Therefore, weirs were chosen (Figure 14) since they function exclusively below top of bank and require only minimal permanent land interest for keys, which could be buried if the landowner chooses.

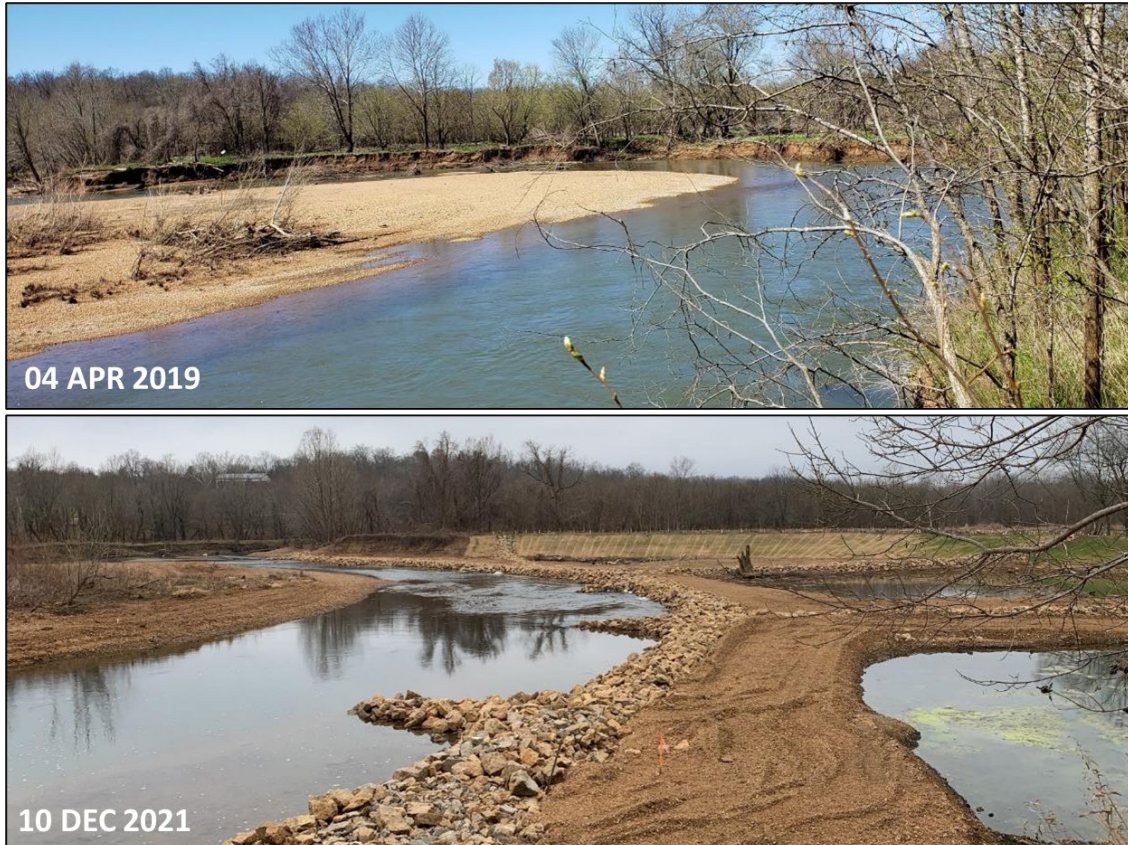
Figure 21. Bank 1 pre- and post-construction. Facing downstream.

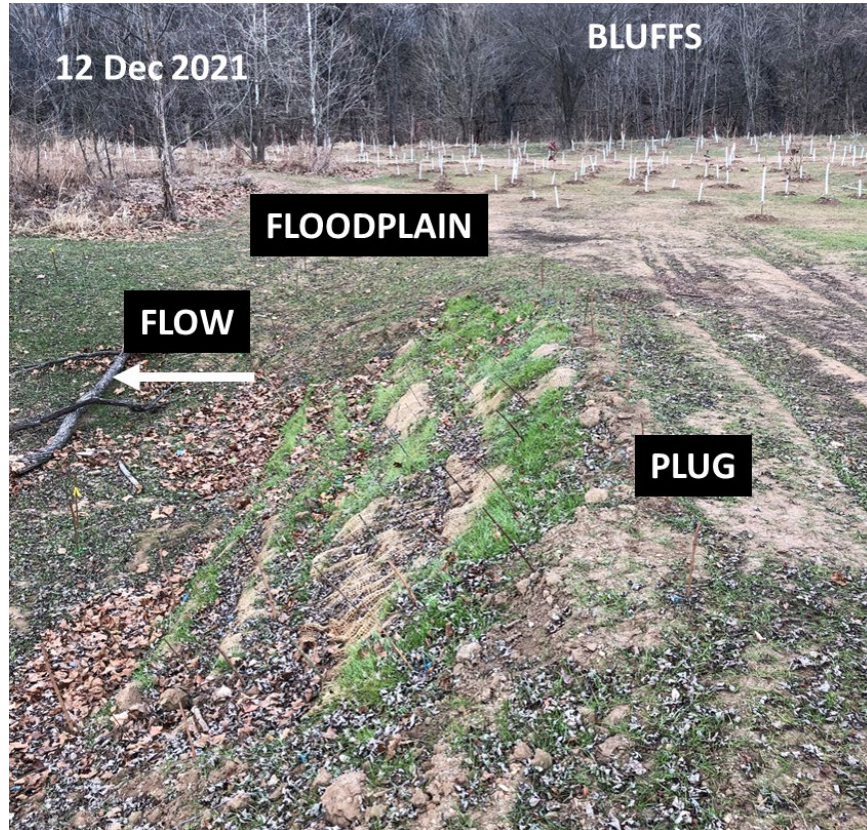
Figure 22. Floodplain and plug, facing RDB bluff; immediately downstream of bank 1, on floodplain.

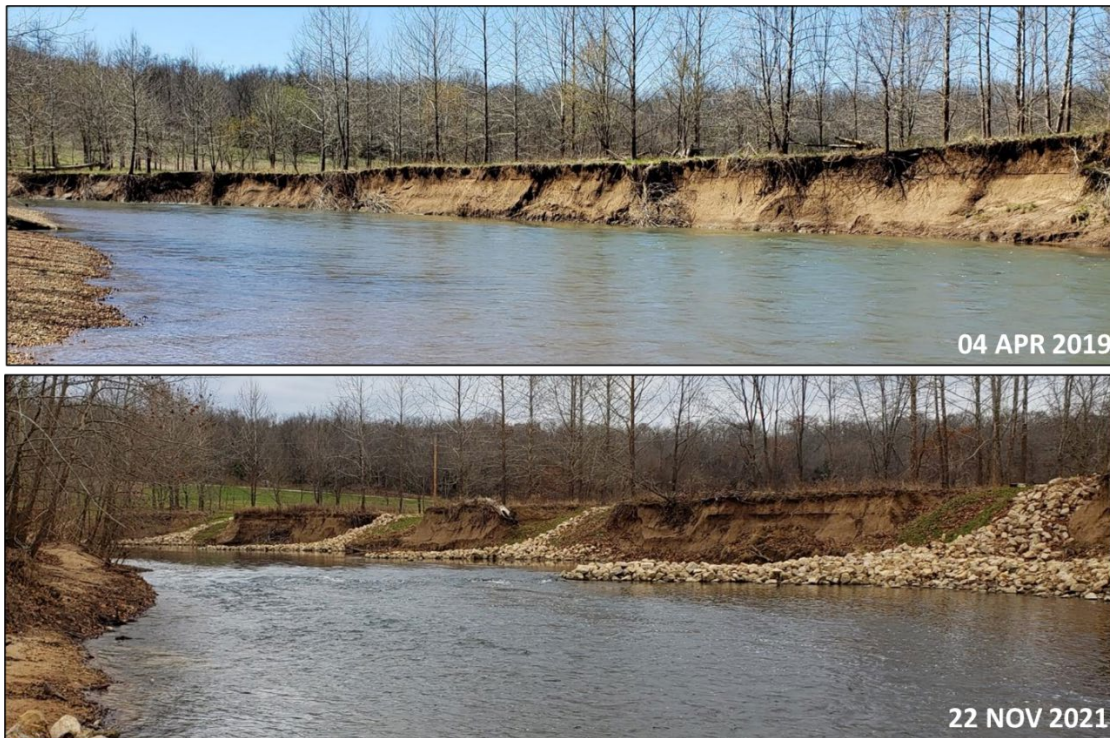
Figure 23. Bank 2 pre- and post-construction. Facing upstream.
