Downstream Impacts of the Rio Coca Regressive Erosion

Introduction

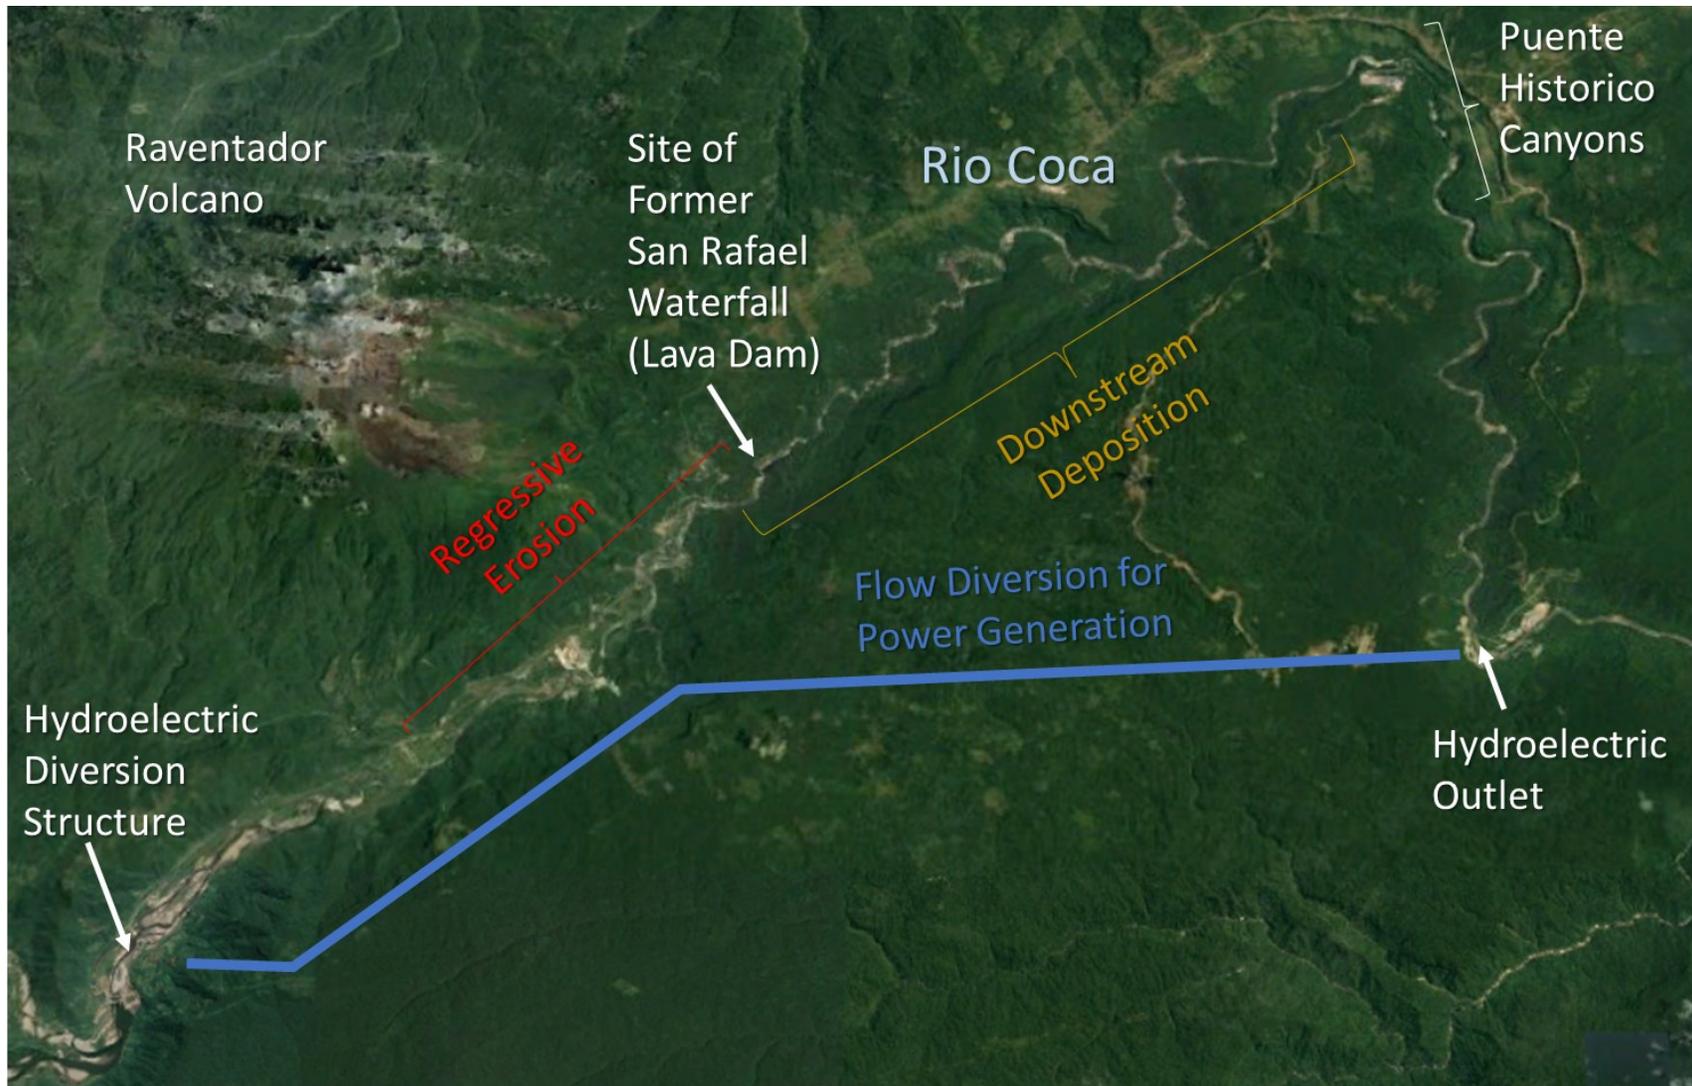
The San Rafael waterfall was the tallest waterfall in Ecuador, situated about 20 km upstream of a reach of the Rio Coca which bends eastward about 130°. This large directional bend in the river alignment (Figure 3) makes it an attractive site for hydropower owing to the substantial head loss over a relatively short longitudinal distance for a diversion tunnel. La Corporación Eléctrica del Ecuador (CELEC), the Ecuadorian energy agency, manages the Coca Coda Sinclair project on this river that diverts water about 20 km upstream of the collapsed lava dam, (Figure 3) to an outlet 65 km downstream of the former dam site. This diverted water drops about 600 m (which the river naturally loses over 65 km) in less than 20 km, creating a more localized head differential for power generation.

Figure 3. Map of the footprint of the hydroelectric infrastructure on the Rio Coca and the effects of the waterfall collapse.
