Victoria Bend Navigation Assessment: Analysis, Modeling, Construction, and Monitoring

Extended Abstract

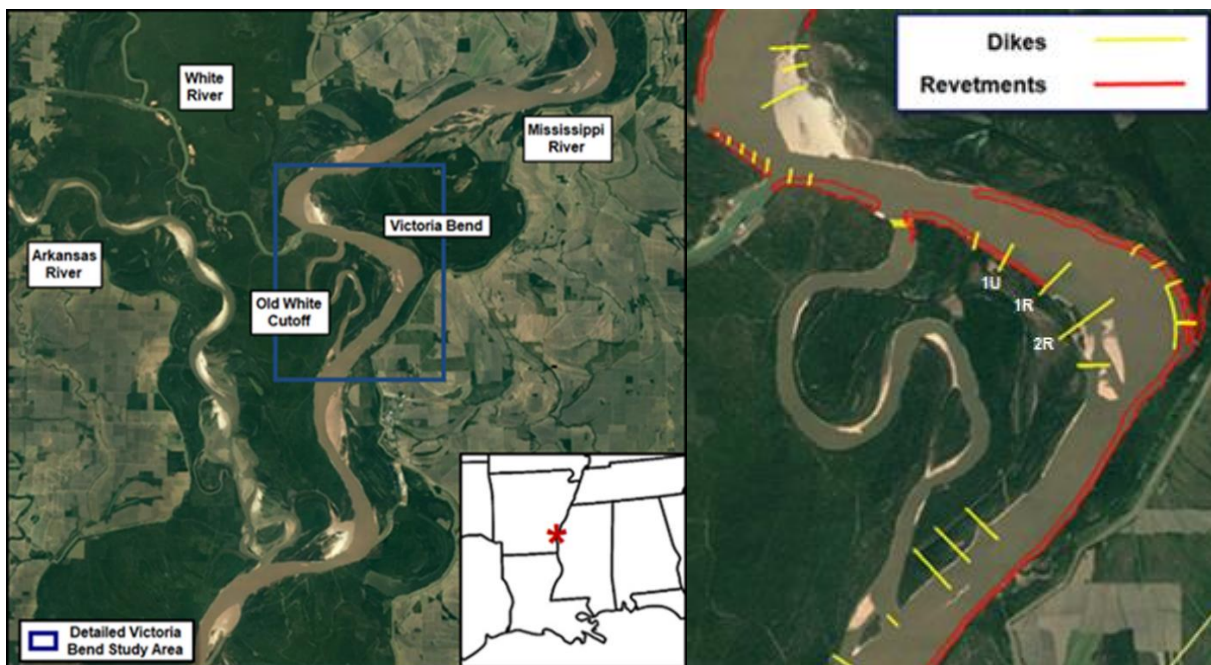
Figure 1. Location Map (left), River Training Structures (right)

Victoria Bend is located on the Lower Mississippi River (LMR) at river mile (RM) 591-599 between Helena, AR and Arkansas City, AR. Both the White River and Arkansas Rivers meet the LMR near the bend and the reach includes the Old White River Cutoff which formed in the early 1900's when the upstream meander of the LMR migrated down valley into the White River. These complexities make this portion of the river one of the more unique reaches on the LMR. Victoria Bend has also historically been a complex and difficult reach to manage from a sediment and navigation perspective, often referred to as the worst reach on the LMR by mariners. Numerous river training structures have been constructed throughout its history and continuously modified in an attempt to improve the channel and reduce dredging needs (Figure 1)

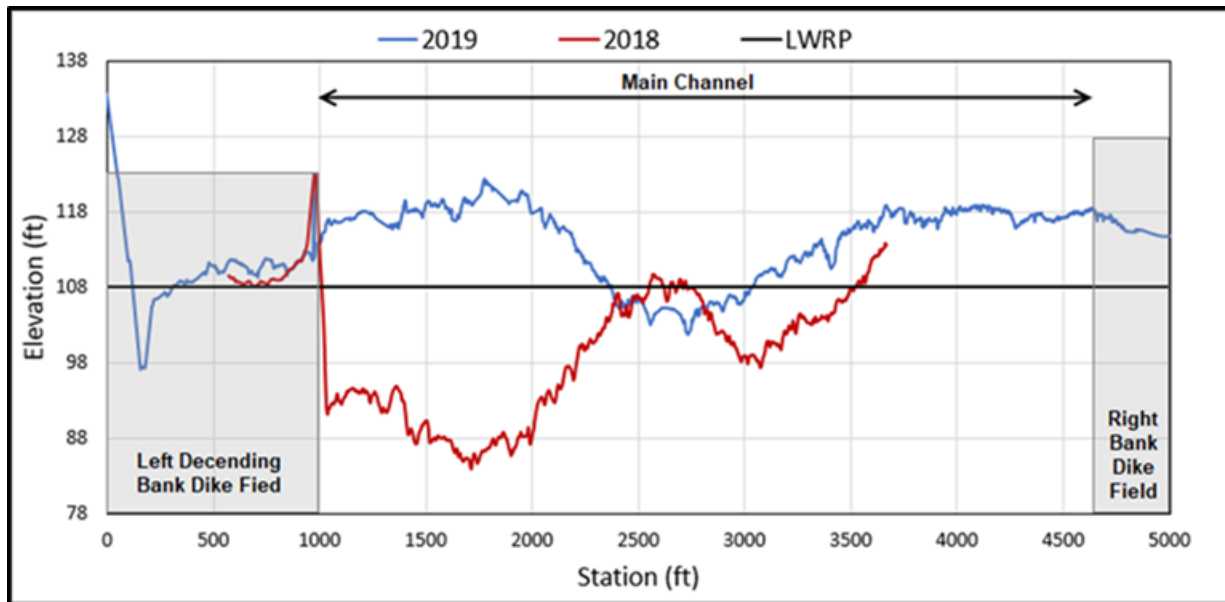
Figure 2. Comparison of pre (2018) and post (2019) flood cross sections. Black line at elevation 108 represents o elevation referenced to the low water reference plane (LWRP) or simplified as low flow water levels.

Even with the all of the river training structures, maintenance dredging has remained necessary to provide an adequate navigation channel. This culminated in 2019 when sedimentation during a major flood event required navigation to be shut down for 13 days, as dredging was needed to reopen the channel, with significant costs to the navigation industry and the USACE. The 2019 flood was a long duration high flow event with water levels above flood stage for almost five months. On the receding limb, groundings were reported well above typical levels for low water navigation concerns and prompted a river bottom survey revealing nearly 30 ft of deposition in parts of the navigation channel (Figure 2).

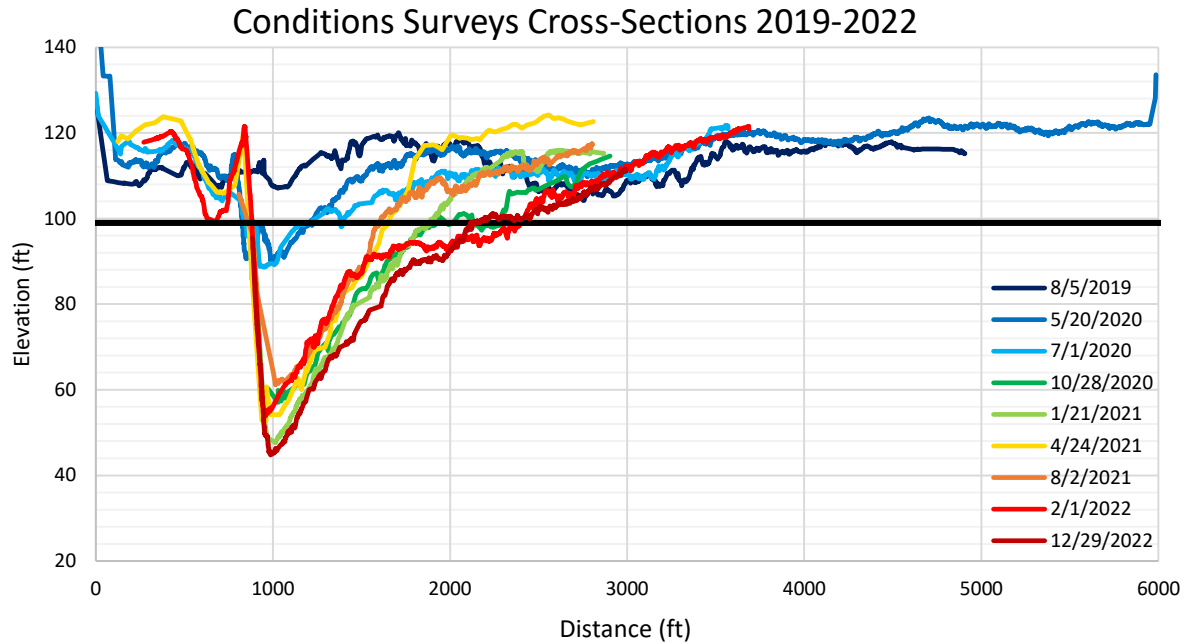
Figure 4. 2019-2022 Channel Monitoring. Black line at elevation 99 represents -9 LWRP or required elevation for navigation during low water conditions.

After the Phase 1 construction, continuous channel monitoring was planned to determine if additional modifications to the reach (Phase 2) would be needed. Phase 2 alternatives, such as bendway weirs to widen the channel or additional channel constriction to deepen the channel were evaluated with future consideration dependent on the channel response to Phase 1. Monitoring to date indicates that navigation channel dimensions have continued to improve since Phase 1 construction. Significant deepening after construction can be seen between the 7/1/2020 survey and the 10/28/2020 survey (Figure 4). Initially there was some concern with the increase in velocities causing difficulty navigating during low water during 2021 but navigation conditions have continued to improve with channel widths in excess of 1000 feet at the -9 LWRP for the most recent surveys. Phase 1 continues to show promise and resiliency as limited issues arose for Victoria Bend during the extreme drought on the LMR during the fall of 2022.
