Quantifying Sediment Deposition within Constructed River Restoration Sites using Repeat Aerial LiDAR

Nathan Holste, Hydraulic Engineer, Bureau of Reclamation, Denver, CO, nholste@usbr.gov

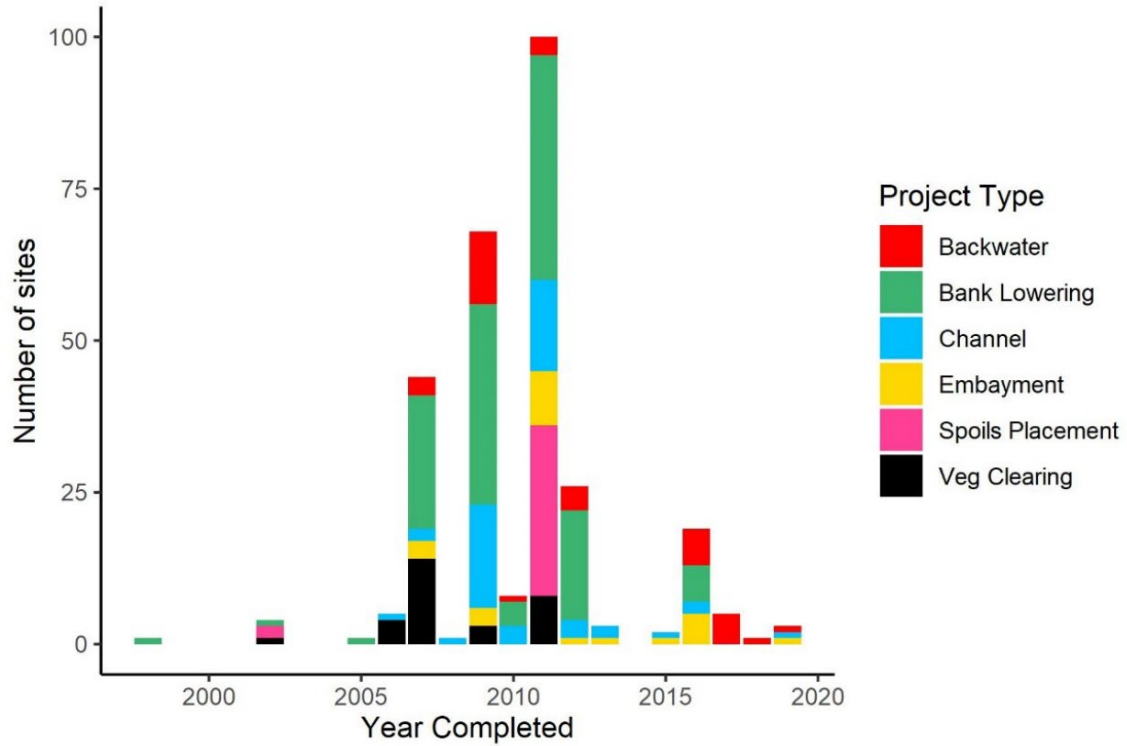
Figure 2. Number of restoration sites constructed by year

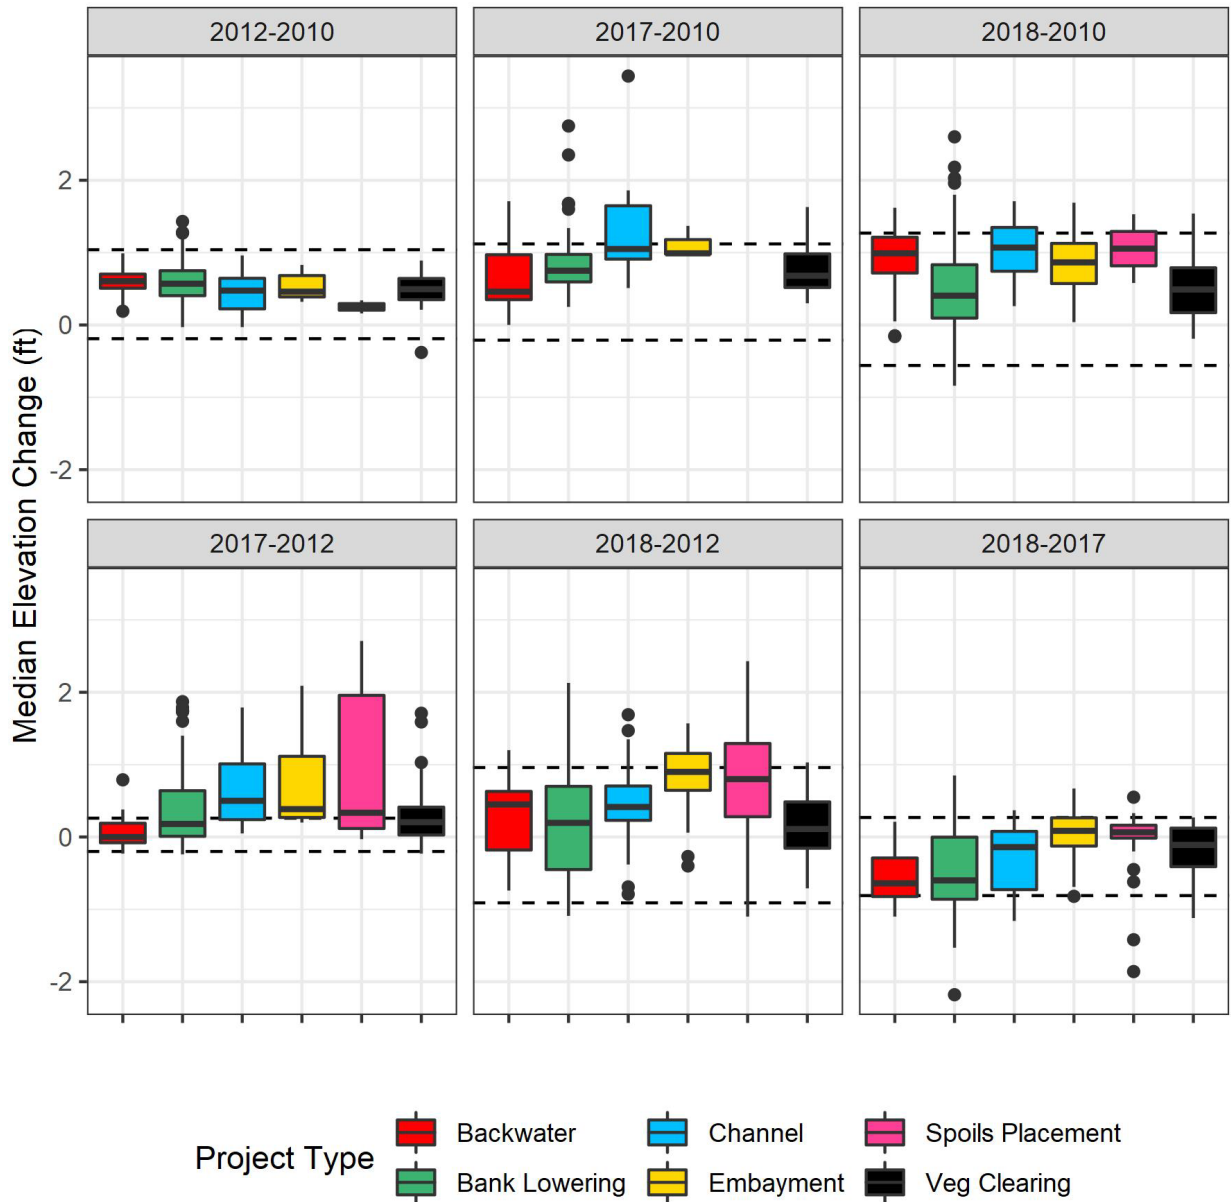
Figure 7. Median elevation change for all restoration sites for each project type constructed prior to the LiDAR period of interest. Horizontal dashed lines represent detection limits (95% and 5% exceedance from stable surface comparisons).

Figure 7 compares median elevation change between different feature types for all sites constructed before the LiDAR interval for all time periods. Horizontal lines are median values for each feature type, boxes are the interquartile range (25% to 75% values) and dots represent outliers. The project types in order from most to least deposition are typically spoils placement, embayment, channel, bank lowering, vegetation clearing, and backwater. The spoils placement and embayment sites are similar because they are constructed along the water's edge, mostly parallel to the direction of flow, without a defined inlet or outlet. These sites are more frequently inundated at lower discharges than other project types. Channels are only connected to the river at inlets and outlets. Most deposition is concentrated at these connection points, which results in lower median elevation change than spoils placement or embayments.

Similar to spoils placement and embayments, bank lowering is a linear feature parallel and adjacent to the main channel. Bank lowering may have experienced less deposition than these features because it was often constructed to a higher design discharge and inundated less frequently. Vegetation clearing sites are usually islands or banks where vegetation is removed without excavating the surface. We hypothesize that excavated sites tend to fill to their pre-construction elevation and vegetation clearing sites are less likely to deposit because they were not excavated. Finally, backwater sites had the least amount of elevation change. This may be caused by the orientation of the river connection relative to the streamline patterns, which allows less sediment to enter the site.
