#184 How Engineered Log Jams (ELJ) of different designs affect channel morphology and hydraulics in a high energy gravel and sand channel

Joanna Crowe Curran, USACE, Seattle, WA, Joanna.C.Curran@usace.army.mil

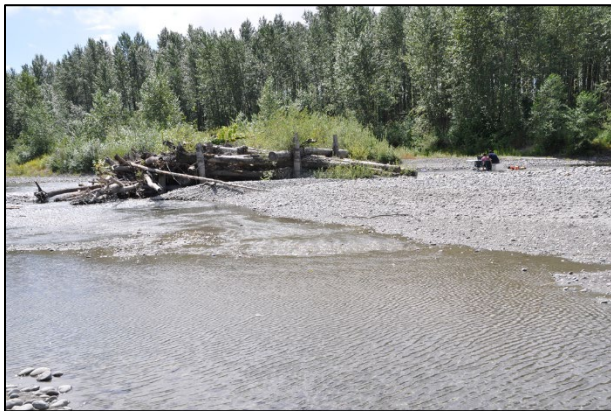
Photos show ELJ in the study reach. The photo on the left is a ELJ at the head of a gravel bar. Note the people on the bar for scale. The photo on the right is looking upstream at a reach where ELJ were constructed on opposite banks.
